## **APPENDIX I-3**

### **CORRESPONDENCE BETWEEN AECOM AND DYNAMIC EARTH**

**Date:** 10/23/19  
**To:** IHCC Files  
**From:** David M. Cregger, P.E., P.G.  
**Subject:** Review of Appendix H

PROJECT NO.: Town of Huntington, Indian Hills Country Club

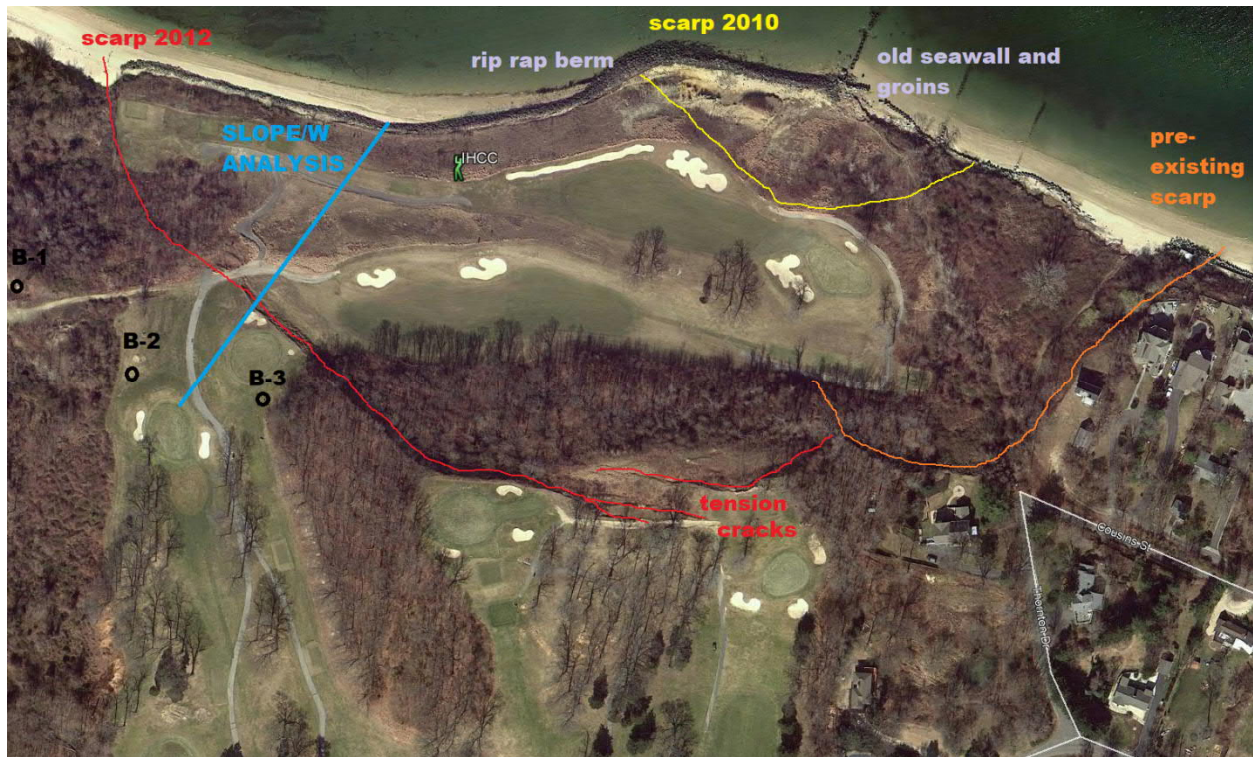
Our professional opinion, for the reasons cited above, is that the 120-ft buffer is inadequate at this time in a known landslide zone (see Figure 1 below). GeoStudio software of SEEP/W and SLOPE/W is appropriate for this work because it allows a seepage analysis and the application of the surcharge can be set back beyond the worst case slip circle. We would recommend that an FS=1.3 or greater be maintained to develop the setback.

**Figure 1. Google Earth Photograph Circa 2012 with Interpreted Landslide Scarps, Tension Cracks, Approximate Boring Locations, and Presumed Slope Stability Profile Location**

At least one extra boring upslope of the failure zone should be made with hollow stem augers to determine a reasonable groundwater level for the slope stability analyses. It would also be prudent to take a second boring or test pit through the land sliding mass just below the existing scarp to see if the depth of sliding can be determined to verify the slope stability model.
