### **GEOTECHNICAL REVIEW FOR TOWN**

## Memorandum

**Date:** 10/23/19  
**To:** IHCC Files  
**From:** David M. Cregger, P.E., P.G.  
**Subject:** Review of Appendix H

AECOM responds by this letter to a request from Town of Huntington for Geotechnical Engineering Services for a Review of Slope Stability Evaluation Report Related to Indian Hills Country Club. The scope of work includes Review & Evaluation of Appendix H – Geotechnical Engineering Reports and Correspondence. We received 3 documents for review:

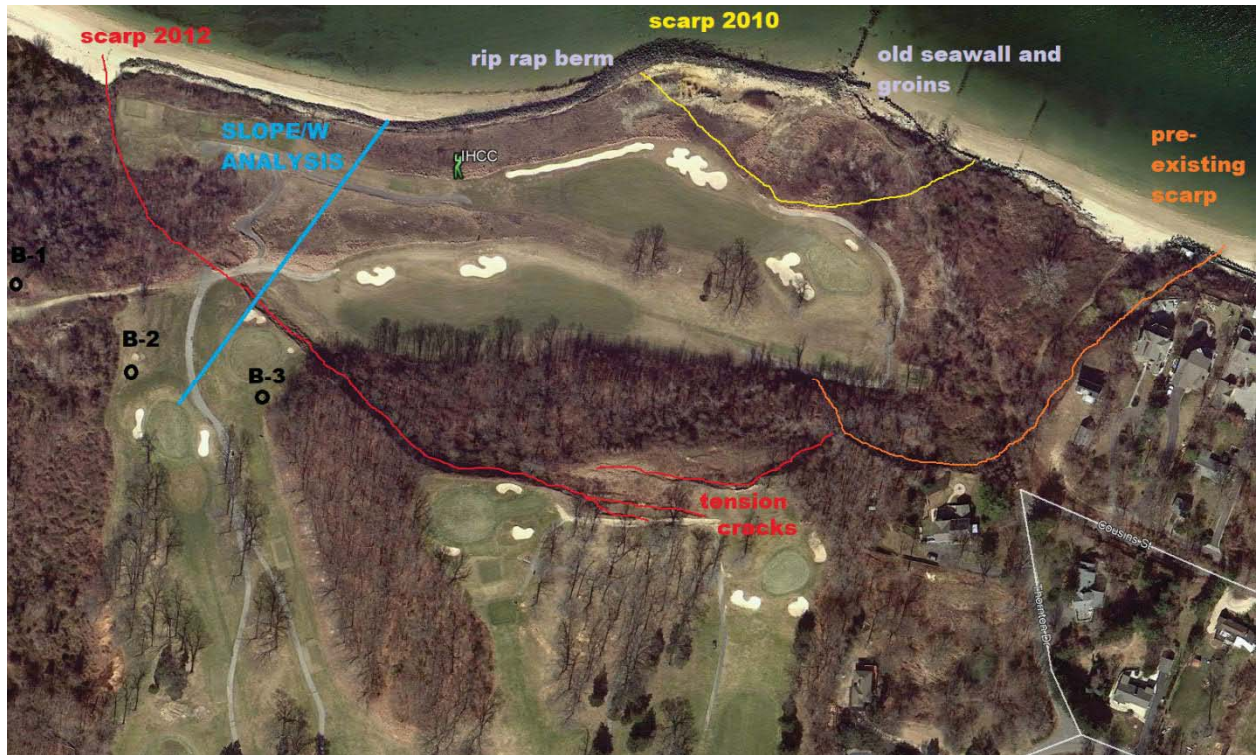
**Figure 1. Google Earth Photograph Circa 2012 with Interpreted Landslide Scarps, Tension Cracks, Approximate Boring Locations, and Presumed Slope Stability Profile Location**

Our professional opinion, for the reasons cited above, is that the 120-ft buffer is inadequate at this time in a known landslide zone (see Figure 1 below). GeoStudio software of SEEP/W and SLOPE/W is appropriate for this work because it allows a seepage analysis and the application of the surcharge can be set back beyond the worst case slip circle. We would recommend that an FS=1.3 or greater be maintained to develop the setback.

Due to the nature of the historical sliding in the area, it will be necessary to develop soil shear strengths based on residual soil parameters. It may be possible to use the existing soil samples, if they were saved in jars, to prepare remolded samples in the laboratory. Simple direct shear testing of remolded samples may provide appropriate parameters if it can be determined what the depth of sliding may be for appropriate normal loads during the test. Triaxial testing of remolded samples may also provide useful results, but may be more expensive.

At least one extra boring upslope of the failure zone should be made with hollow stem augers to determine a reasonable groundwater level for the slope stability analyses. It would also be prudent to take a second boring or test pit through the land sliding mass just below the existing scarp to see if the depth of sliding can be determined to verify the slope stability model.
