## **APPENDIX I-6**

**AECOM Memo**  
*September 16, 2020*

**Date:** 9/16/2020  
**To:** IHCC Files  
**From:** David M. Cregger, P.E. (NY), P.G. (NY)  
**Subject:** Update of Landslide Soils Properties

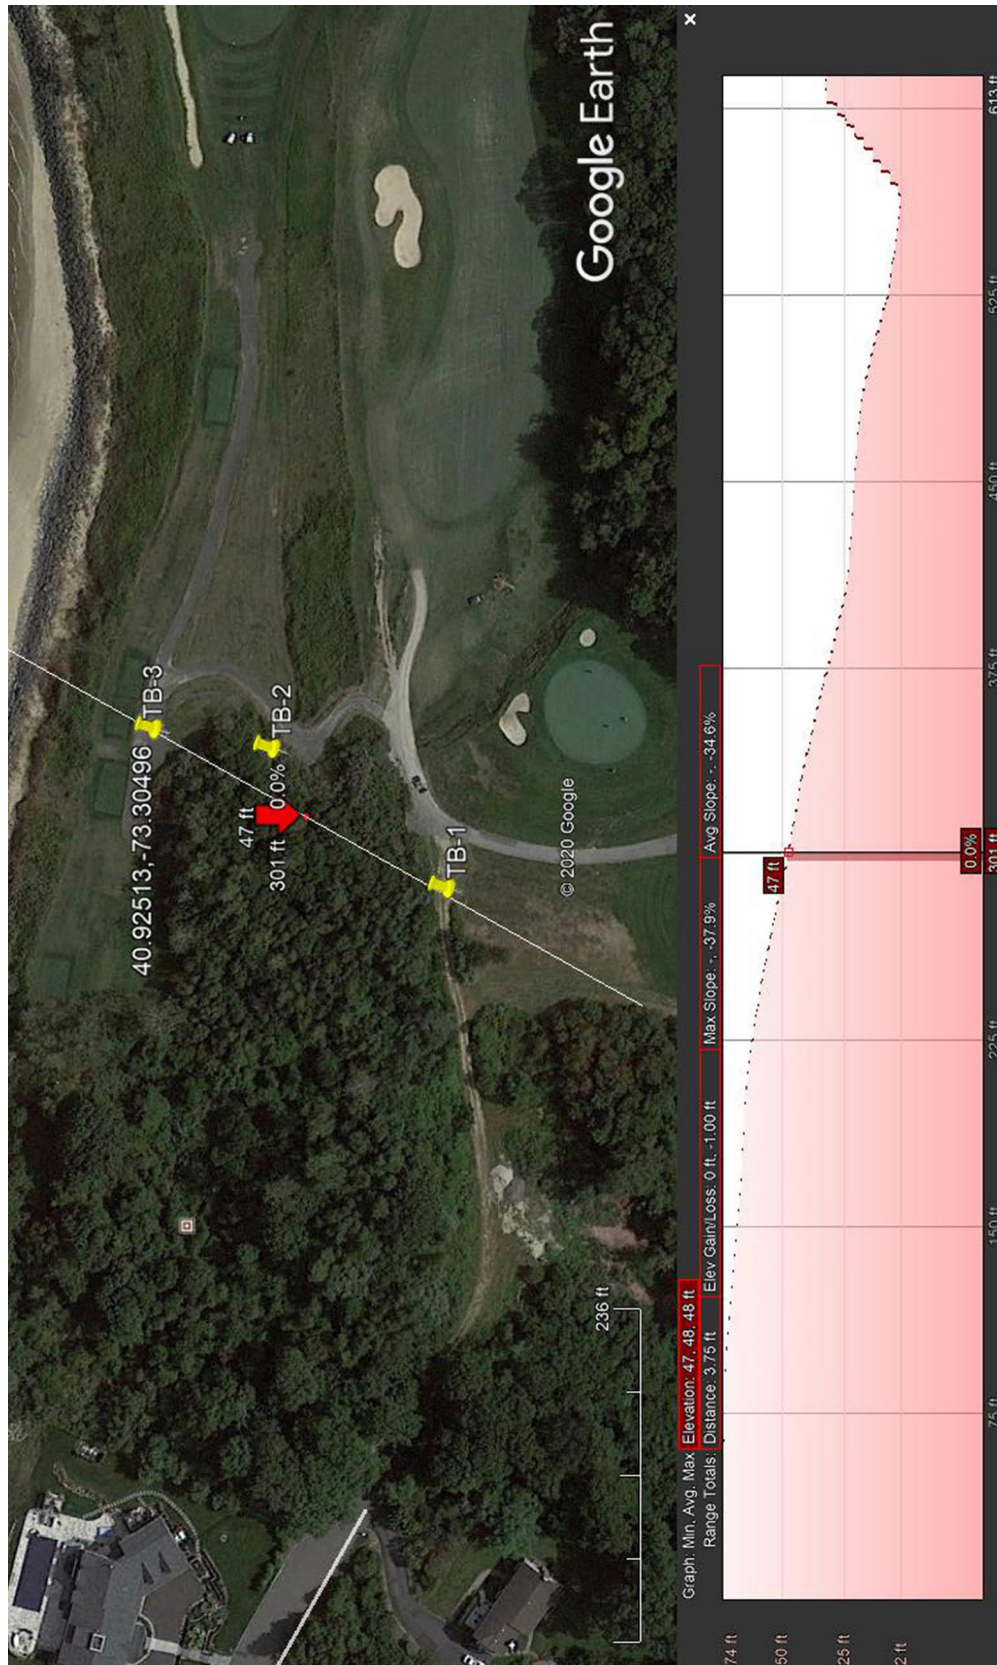
Figure 1. Topographic Profile along Three Borings

Based on the new data from 3 borings shown on Figure 1 and lab tests, we reduced the cohesion of the Gardiners clay deposit from 650 psf to 500 psf in our simplified analysis and raised the water table to approximate Elevation +50 in the pre-existing landslide area. This conservative approach indicates a Factor of Safety greater than 1.3 as we previously recommended with the 300 psf surcharge of the buildings.

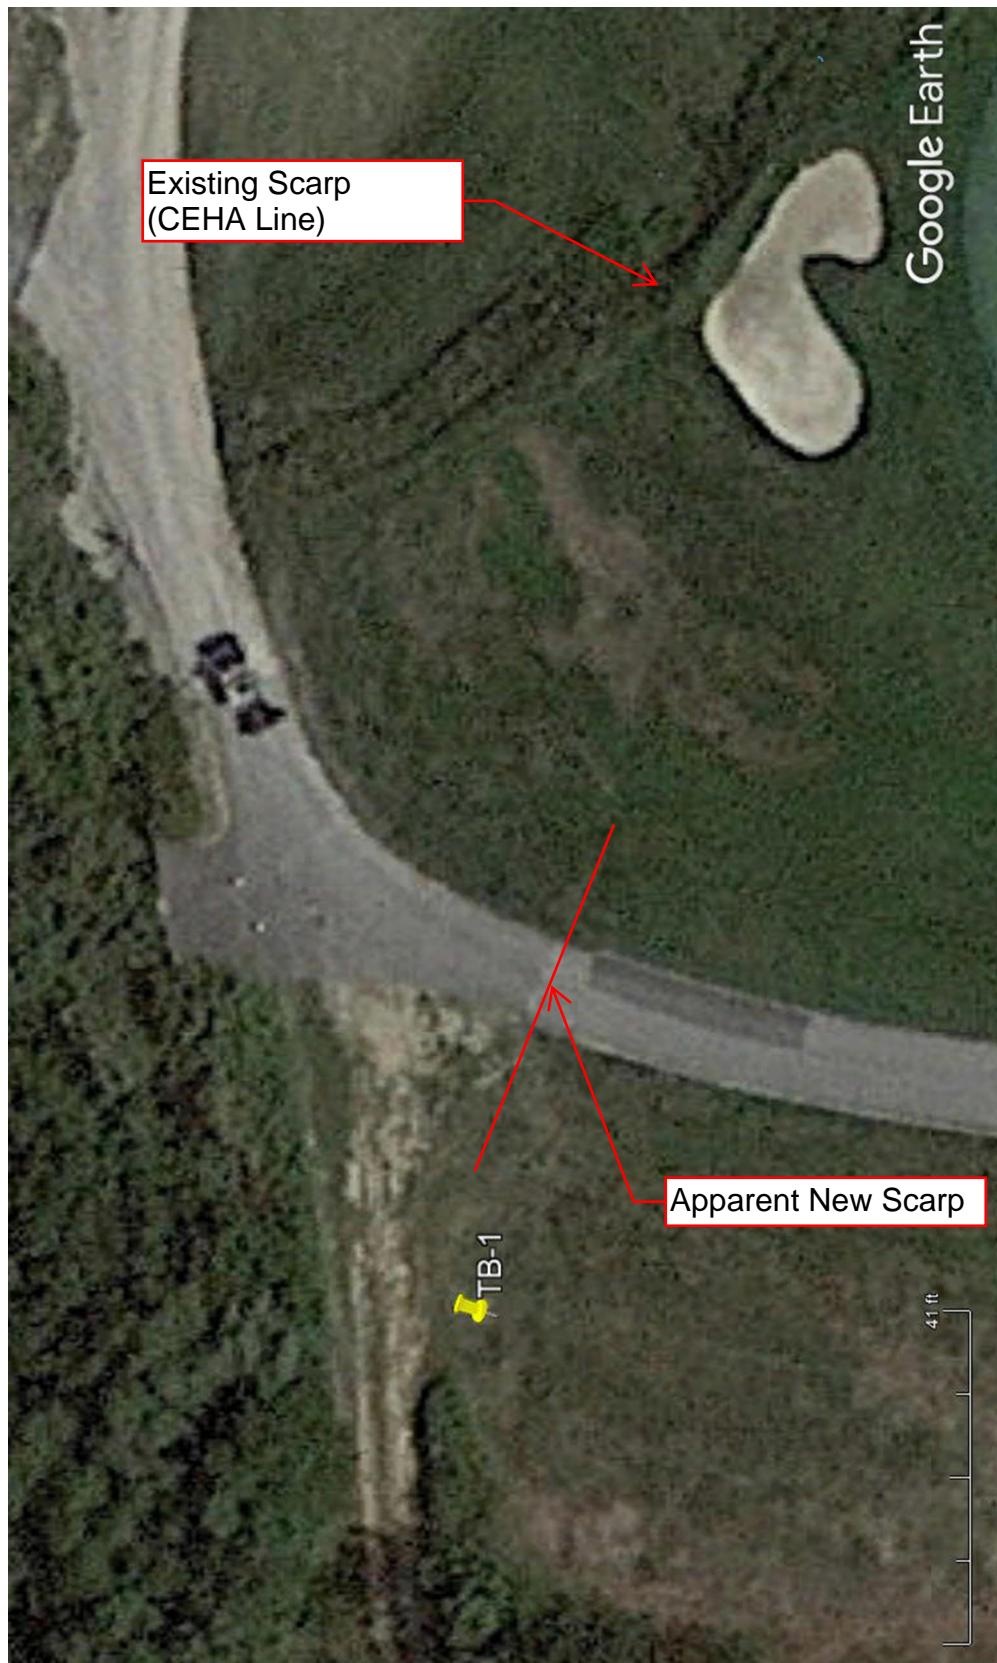
Figure 2. Possible New Scarp North of TB-1

Considering the new data provided, we now conclude that 120 feet may be enough of a buffer *provided the hydrology and shoreline conditions outside the Coastal Erosion Hazard Line do not change*. A possible new scarp is visible on recent Google Earth imagery between borings TB-1 and TB-2 as shown on Figure 2 where the golf cart path is damaged. Continued survey deformation monitoring at the golf course is recommended.

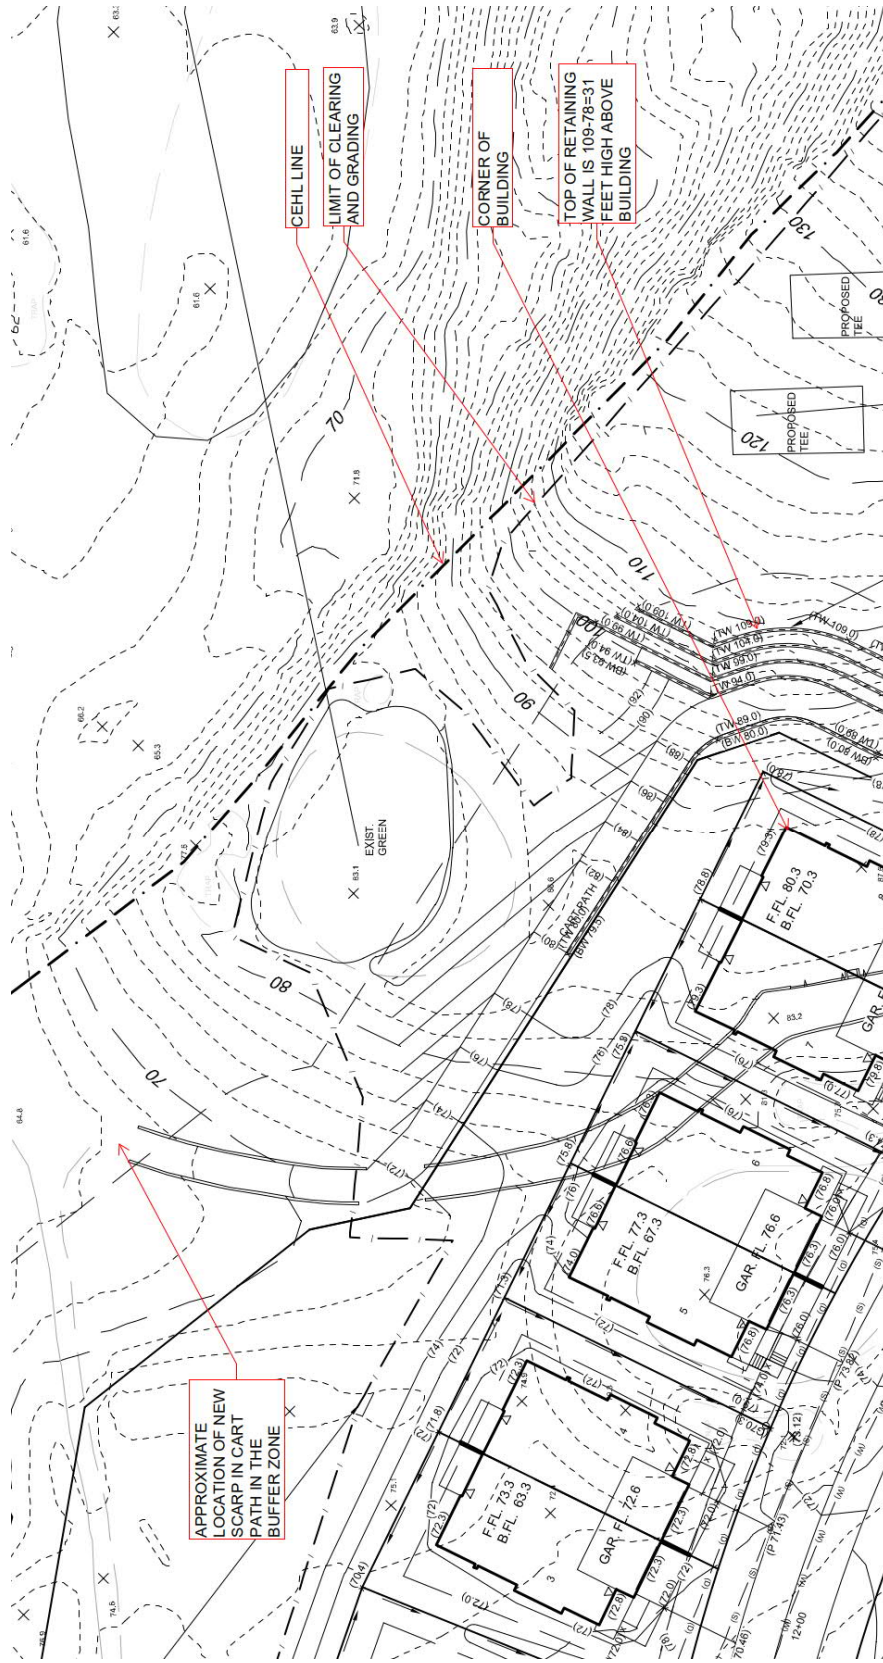
We remain concerned that a 30-feet high retaining wall is being constructed near the northwest portion of the site within the buffer zone (see Figure 3). Several housing units may face damage in the future. Subdivision approval plans prior to ground-breaking should include detailed slope stability and drainage calculations to be submitted for review to the Town of Huntington.
