## **APPENDIX I-7**

### **Response to AECOM Memo of September 16, 2020**

**RE: The Preserve at Indian Hills**  
21 Breeze Hill Road  
Northport, Town of Huntington  
Suffolk County, NY  
Dynamic Earth Job# 3114-99-001EC

**Date:** 9/16/2020  
**To:** IHCC Files  
**From:** David M. Cregger, P.E. (NY), P.G. (NY)  
**Subject:** Update of Landslide Soils Properties

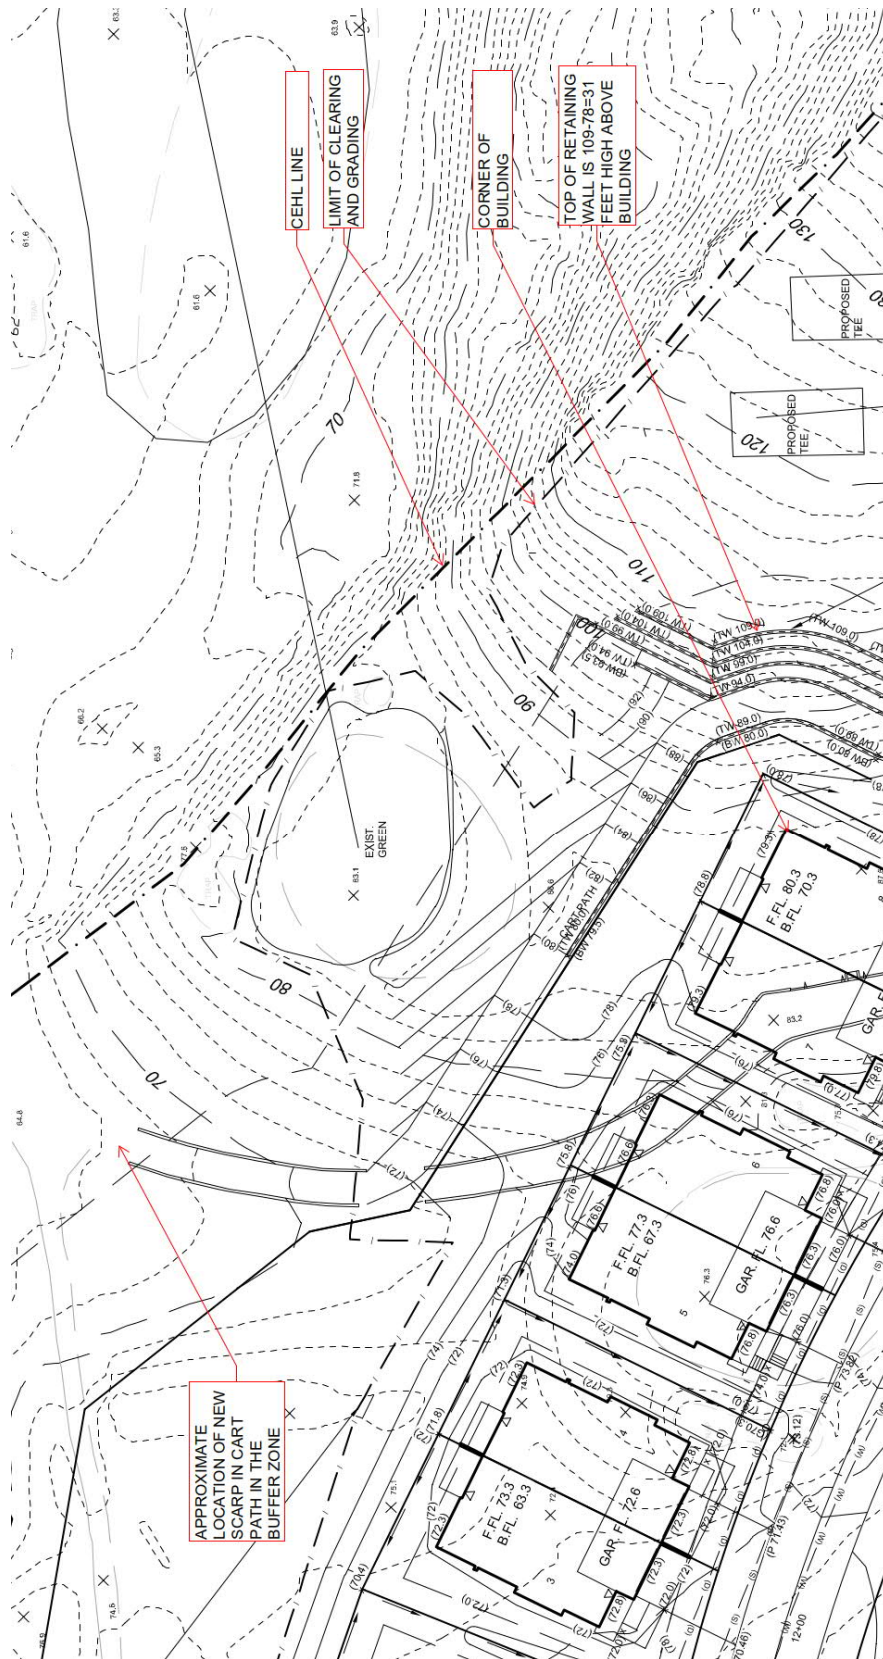
**COMMENT:** "We remain concerned that a 30-foot high retaining wall is being constructed near the northwest portion of the site within the buffer zone (see Figure 3). Several housing units may face damage in the future. Subdivision approval plans prior to ground-breaking should include detailed slope stability and drainage calculations to be submitted for review to the Town of Huntington."

We remain concerned that a 30-feet high retaining wall is being constructed near the northwest portion of the site within the buffer zone (see Figure 3). Several housing units may face damage in the future. Subdivision approval plans prior to ground-breaking should include detailed slope stability and drainage calculations to be submitted for review to the Town of Huntington.

**RESPONSE:** While Dynamic is not involved with the design of these retaining walls, it is our understanding that these walls are being designed by a licensed engineer and that details regarding their design (including internal and global stability and drainage calculations) will be submitted during the permitting/approval process with the Town of Huntington.
