DRAFT ENVIRONMENTAL IMPACT STATEMENT

Kiruv Estates Subdivision Application

Volume 2 of 2 Appendices B-N

NP&V Project No. 97110

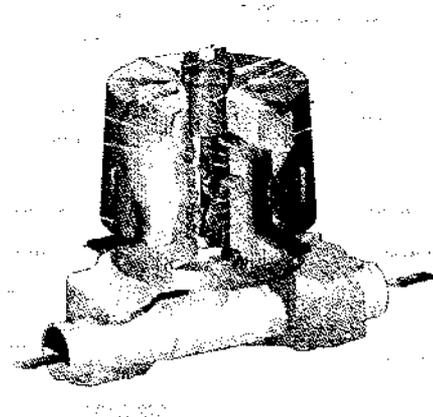
Figure 1. The StormFilter Cartridge

Water continues to pass through the filter media and into the cartridge's center tube. The air in the cartridge is displaced by the water and purged from beneath the filter hood through the one-way check valve located in the cap. Once the center tube is filled with water (approximately 18 inches deep), there is enough buoyant force on the float to open the float valve and allow the treated water in the center tube to flow into the under-drain manifold. This causes the

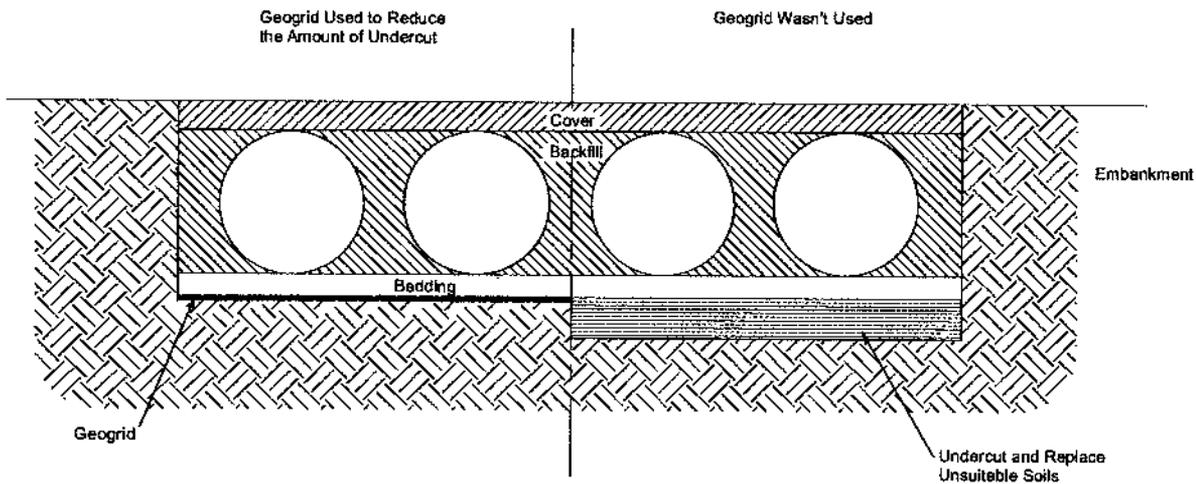
Figure 1

In some cases a stiff reinforcing geogrid can be used to reduce the undercut. It is important to properly analyze the underlying soils to make sure that the applied loads do not exceed the capacity of the underlying soils causing settlement when geogrids are used.

The foundation subgrade needs to be graded to a uniform or slightly sloping grade prior to the placement of the bedding material. If the subgrade is a clay or is relatively non-porous and the construction sequence will last for an extended period of time, it is best to slope the grade to one end of the system. This will enable excess water to be drained quickly, preventing saturation of the subgrade.

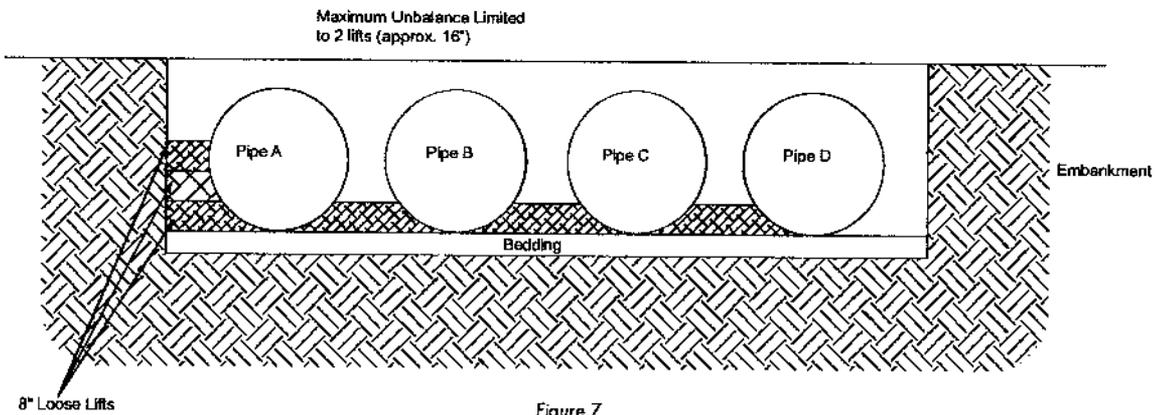
Figure 7

The backfill shall be placed in 8" loose lifts and compacted to 90% AASHTO T99 standard proctor density. The backfill shall be placed in a balanced manner making sure that no more than a two-lift differential is present from one pipe side to the other during the backfilling process. Backfill differential heights from one side of the pipe to the other in excess of the above recommendations can cause pipe distortions or unwanted movement.

As backfill is placed between the pipes it must be kept balanced from side to side as well as advanced at the same rate along the length of the detention system. In other words if you place the first lift between pipe A and B for a distance of 25 feet along the length of the system, then 25 feet of fill needs to be placed between pipes B and C and so forth until all pipes are backfilled equally.

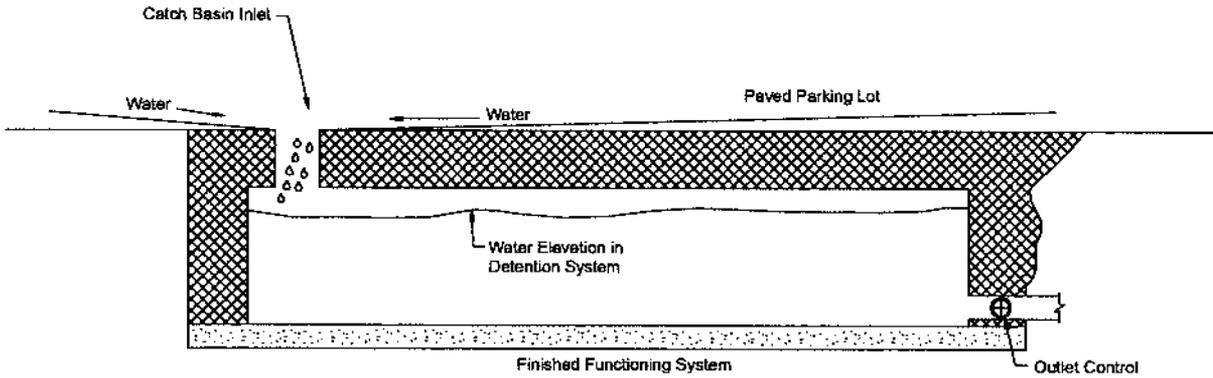
Figure 12

Since most of these systems are constructed at a grade below elevation for the surrounding site, rainfall can cause the excavation to fill with water rapidly. This rapid influx of water can potentially cause floatation and movement of the previously placed pipes. To help mitigate potential problems, it is best to start the system at the outlet or down stream end with the outlet already constructed to allow a route for the water to escape. Temporary diversion measures to handle flow may be required due to the restricted nature of the outlet pipe.

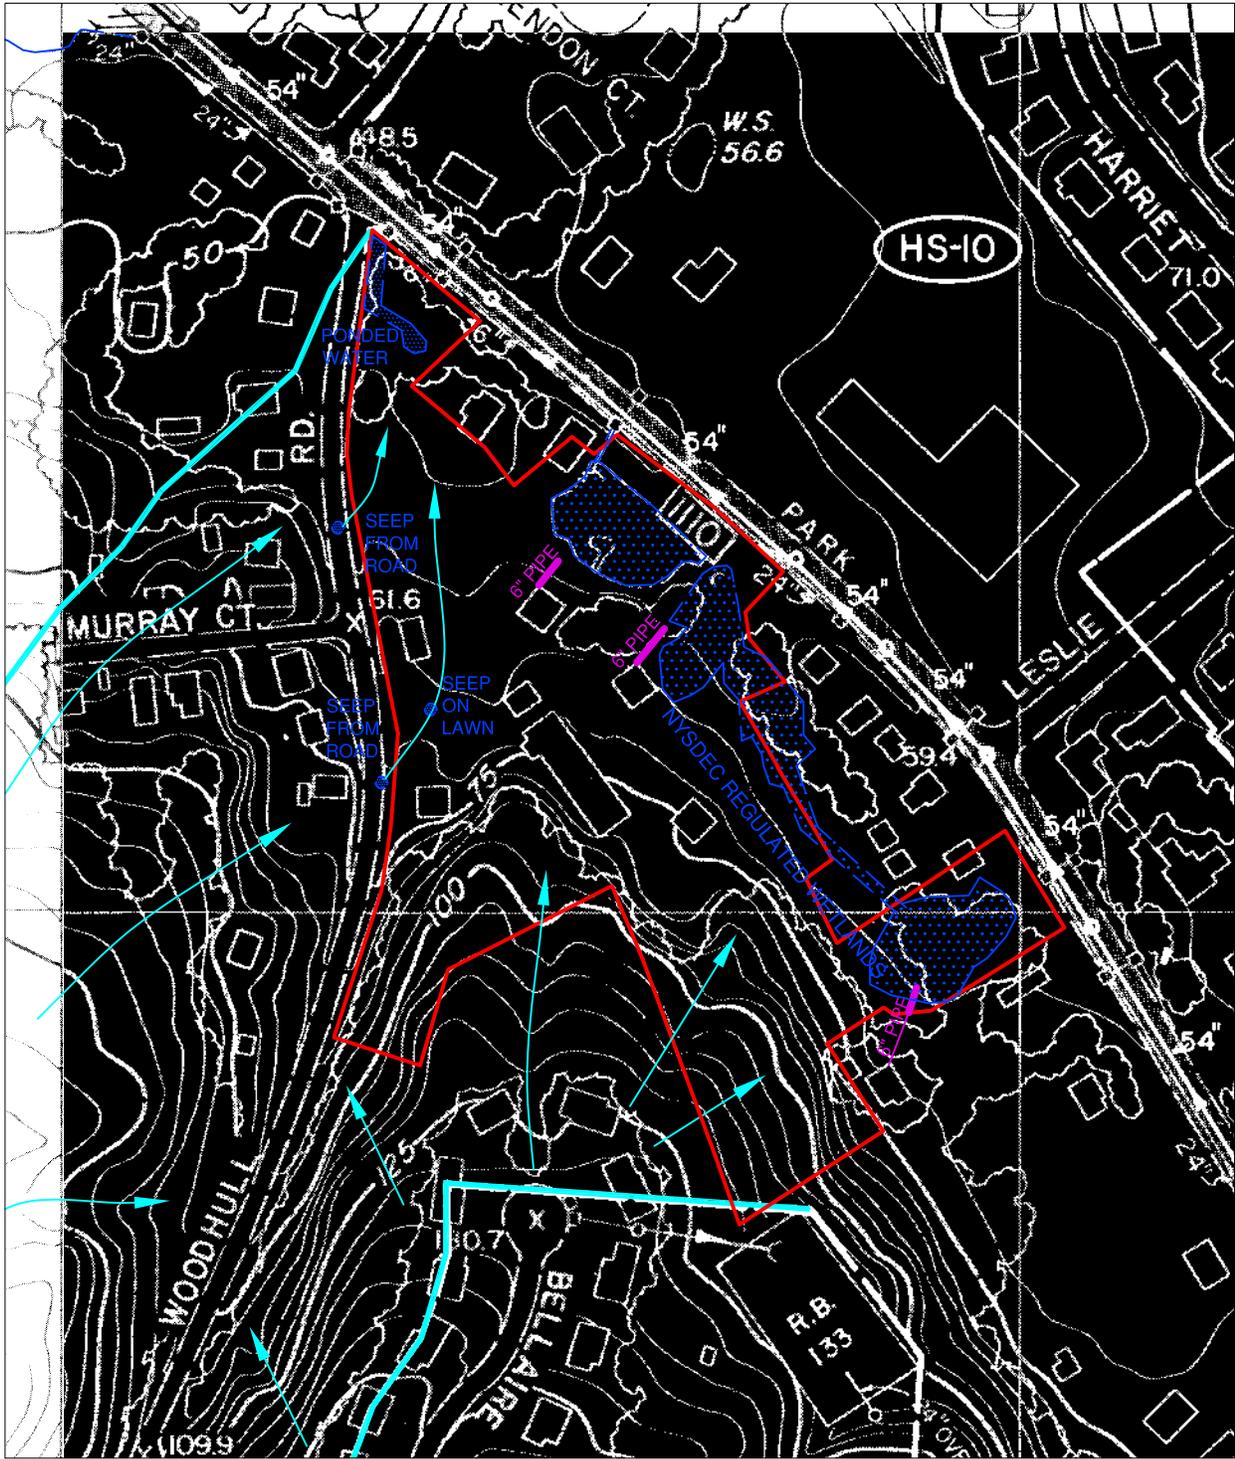
FIGURE 7

WATER SHED & HYDROLOGICAL FEATURES

Source: Comprehensive Storm Drainage Study Plan for Town of Huntington, 1980
Scale: 1" = 300'

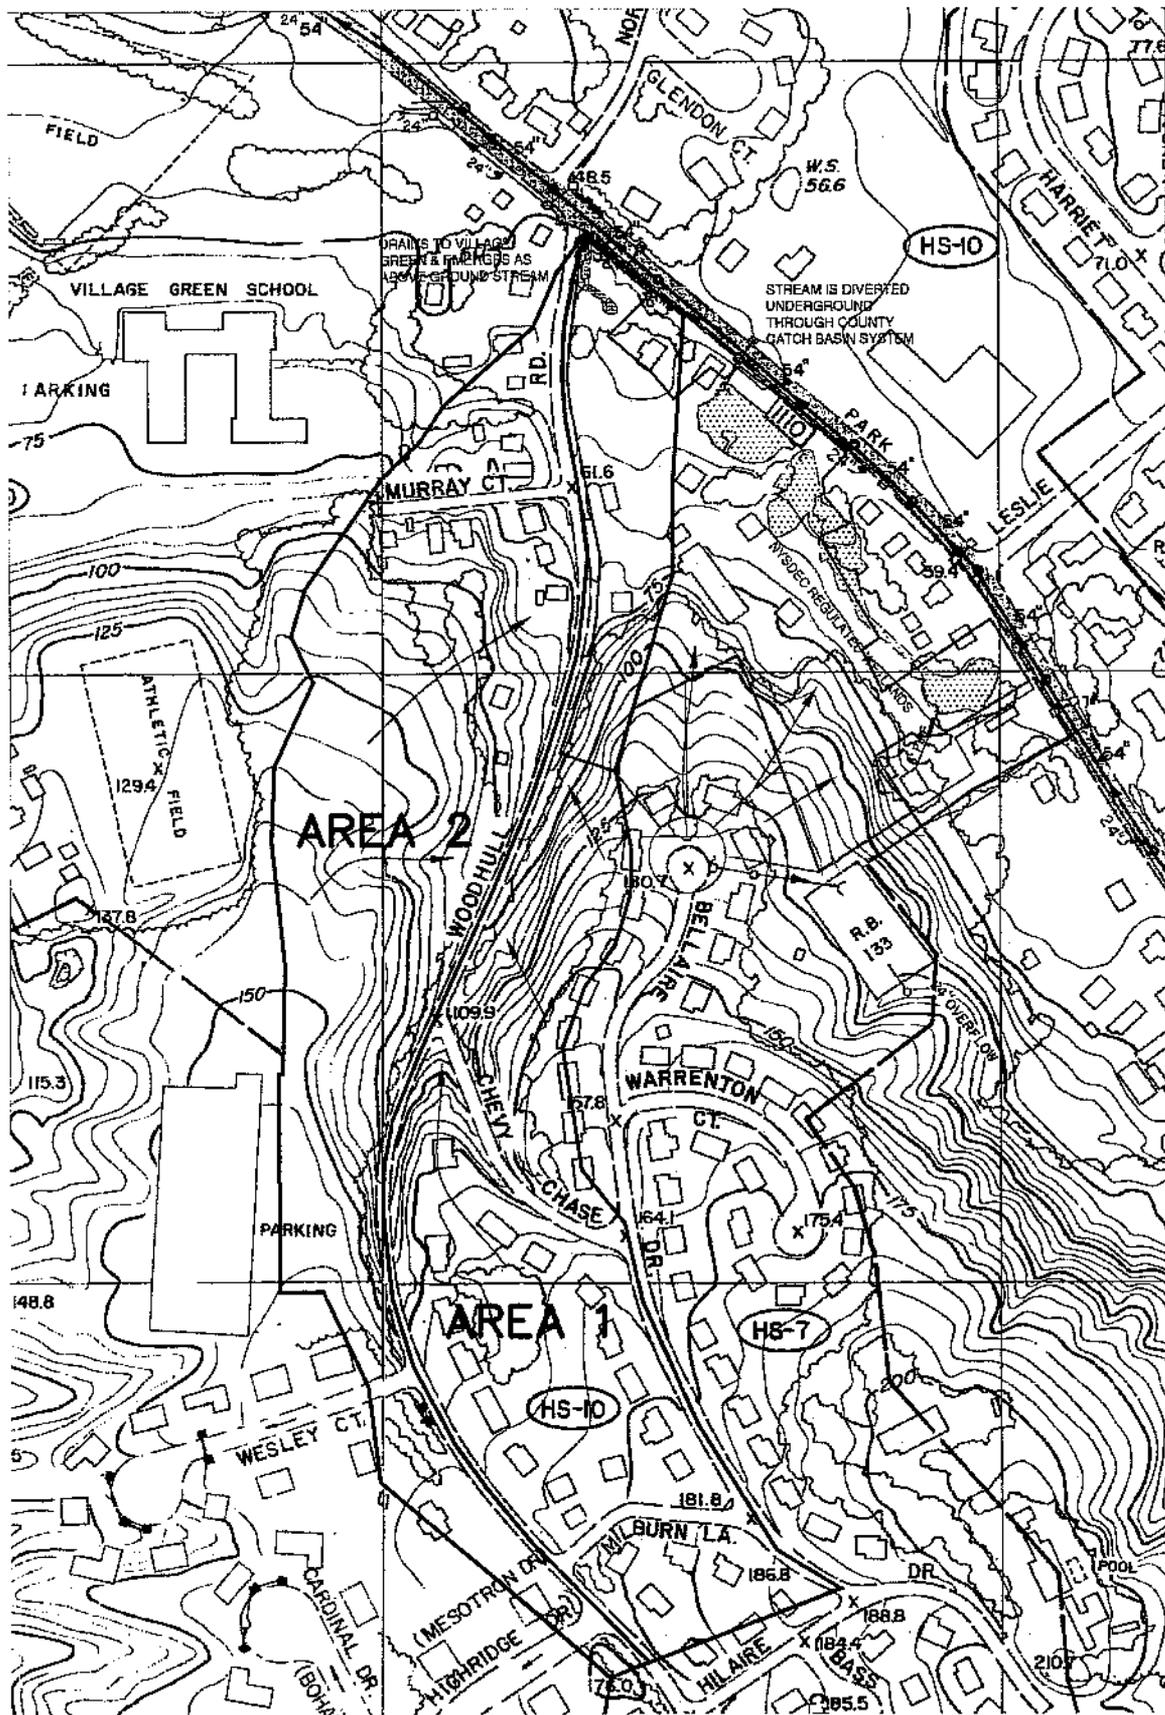
FIGURE 2-1
PRE-DEVELOPED SHED AREAS

Sub-shed Area	CN Values
1	70
2	67

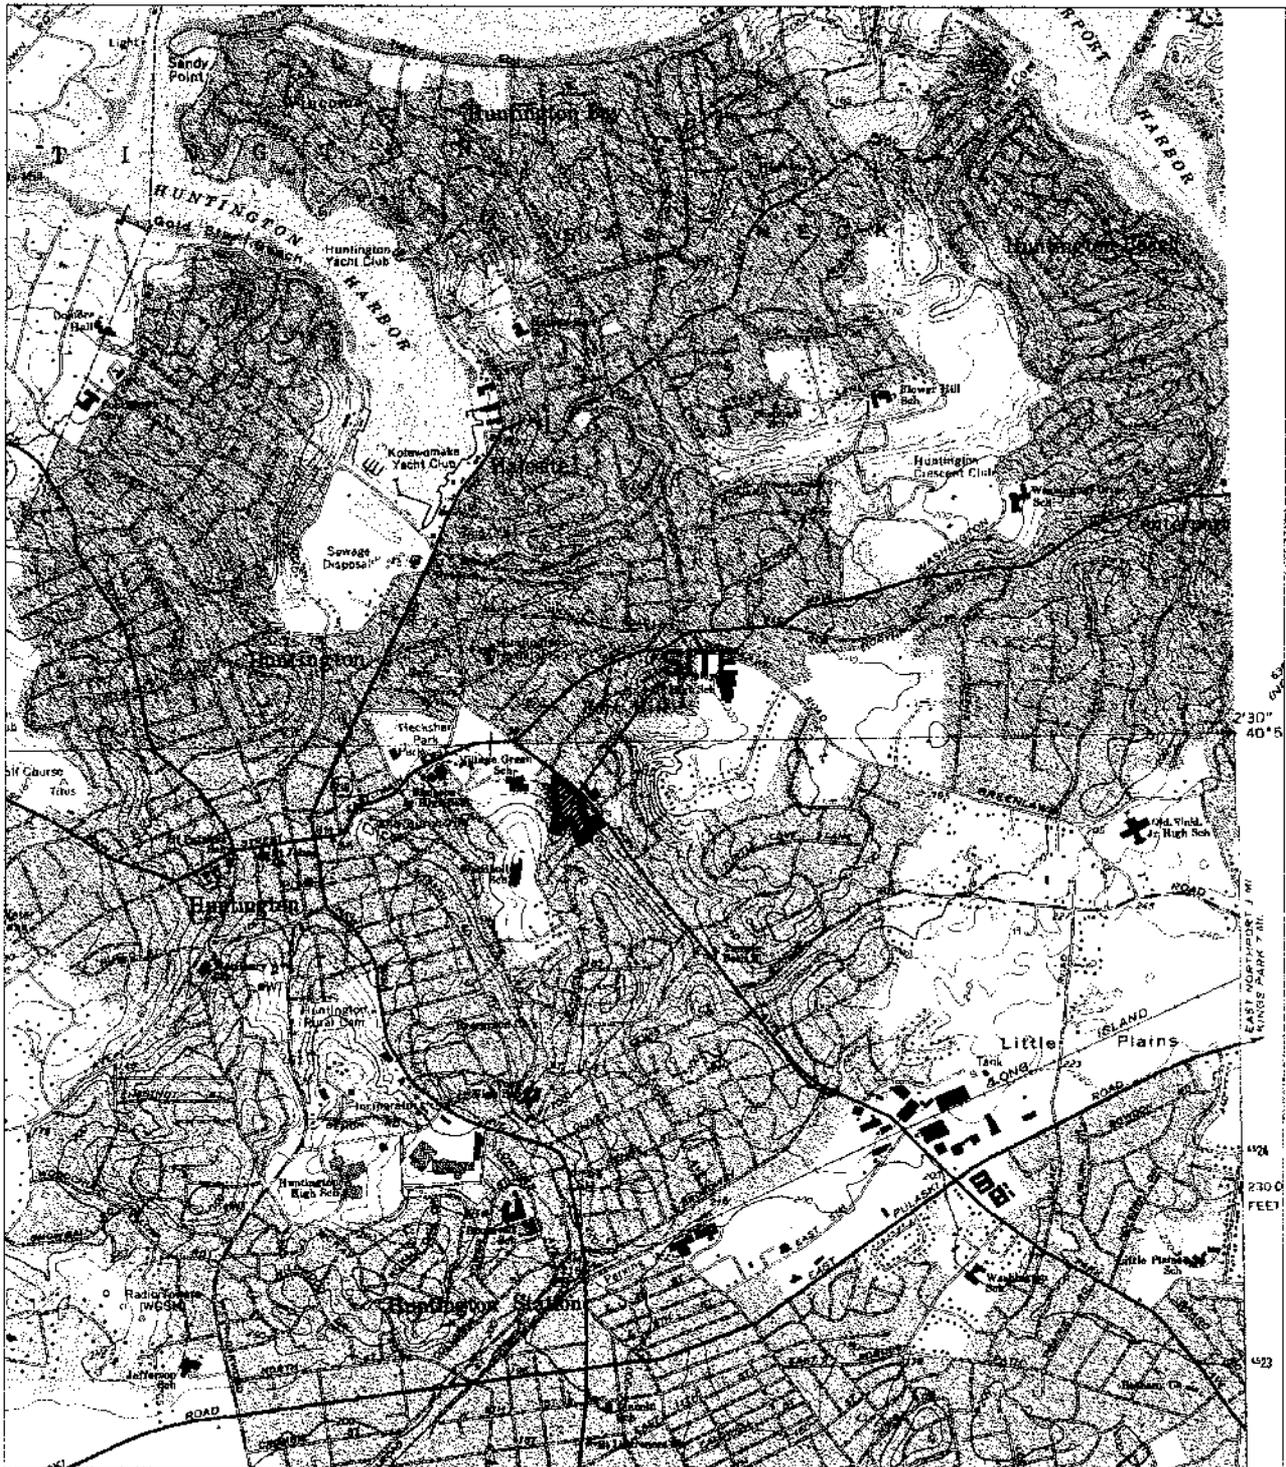
TOPOGRAPHIC MAP

Source: USGS Topographic Maps, Huntington & Lloyd Harbor Quadrangles
Scale: 1" = 3,000'

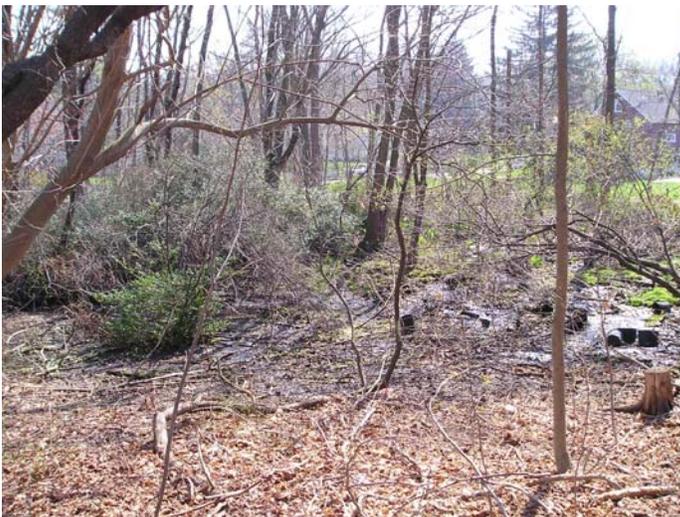
Photo 15.
View of narrow portion of freshwater wetland facing Park Avenue, looking northeast.

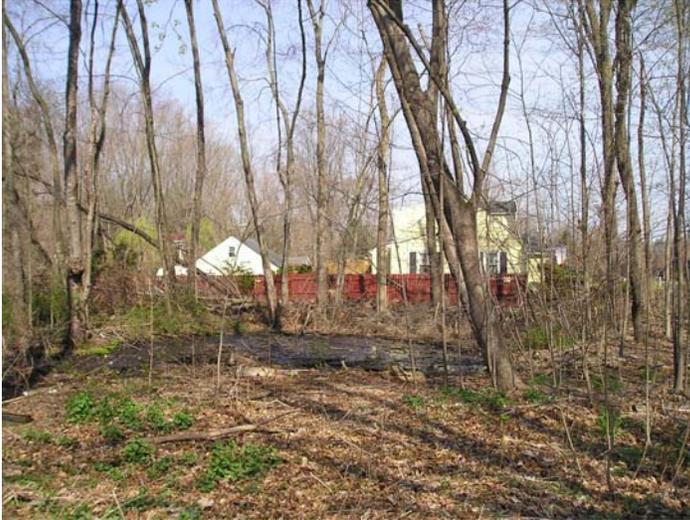
Photo 16.
View of wetland area on south portion of property, looking northwest.

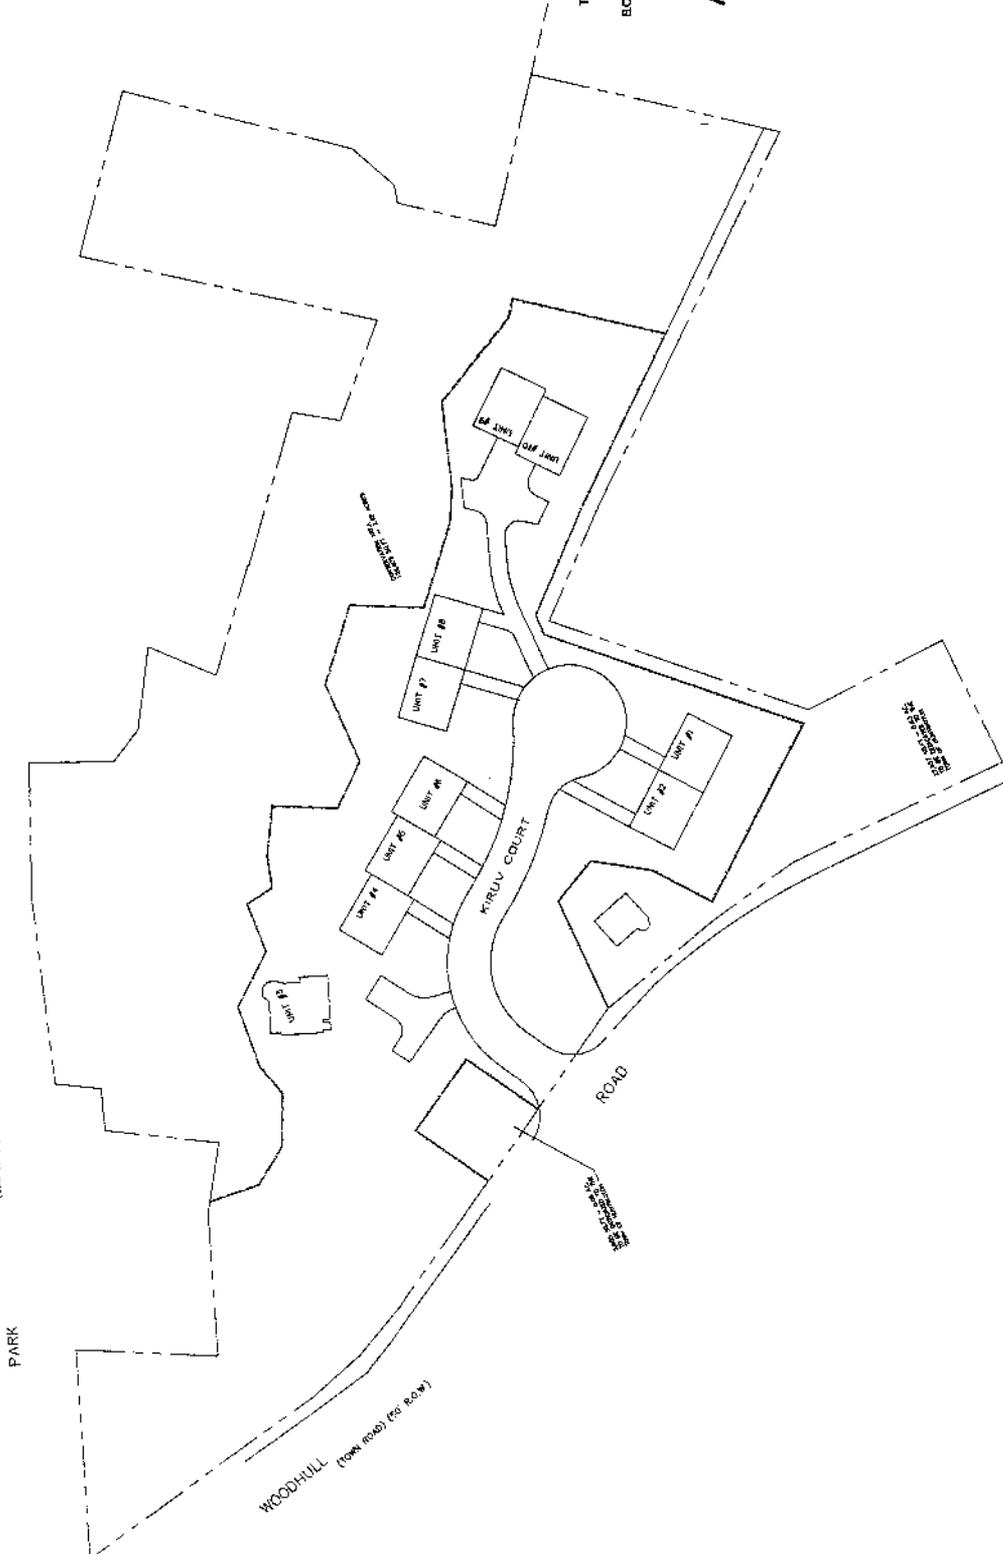
KIRUV ESTATES

PARK
(C.R. 354) (60' R.O.W.) (E.G. 30' AVENUE)

LOCATED AT
HARTINGTON
TOWN OF HARTINGTON, WESTCHESTER COUNTY, NEW YORK
SECTION DIST. 0400, SECT. 0200, B.L.K. 0100
LOT# 038,000, 040,000, AND 042,000
SECTION DIST. 0400, SECT. 0200, B.L.K. 0200, LOT 107,000

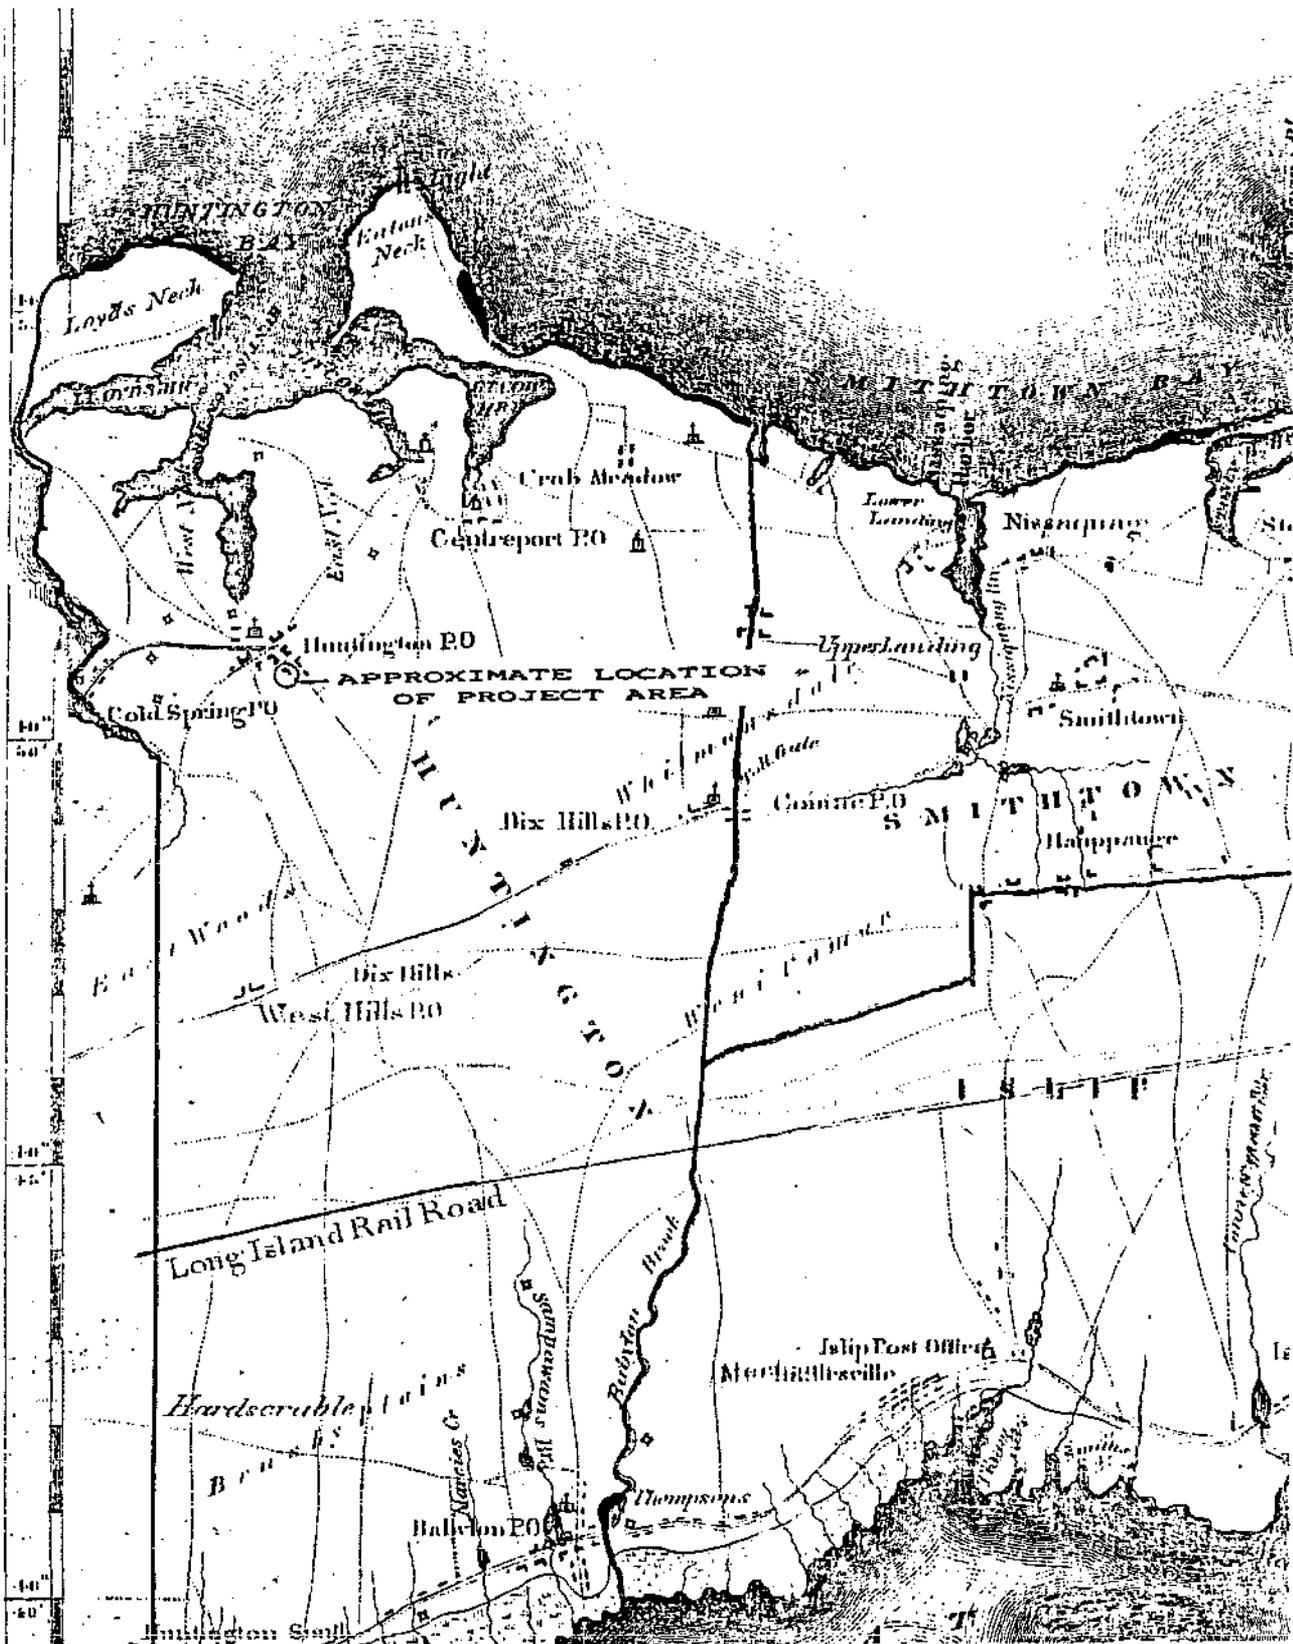
Figure 3 From the 1829 Burr map.

The history of land use within and adjacent to the project parcels is told by the series of maps and atlases examined as part of this research. The earliest of these is the 1829 Burr map presented here as Figure 3. This map is at a small scale and does not provide much detail. It does appear to show Park Avenue and settlement in the vicinity of the project area.

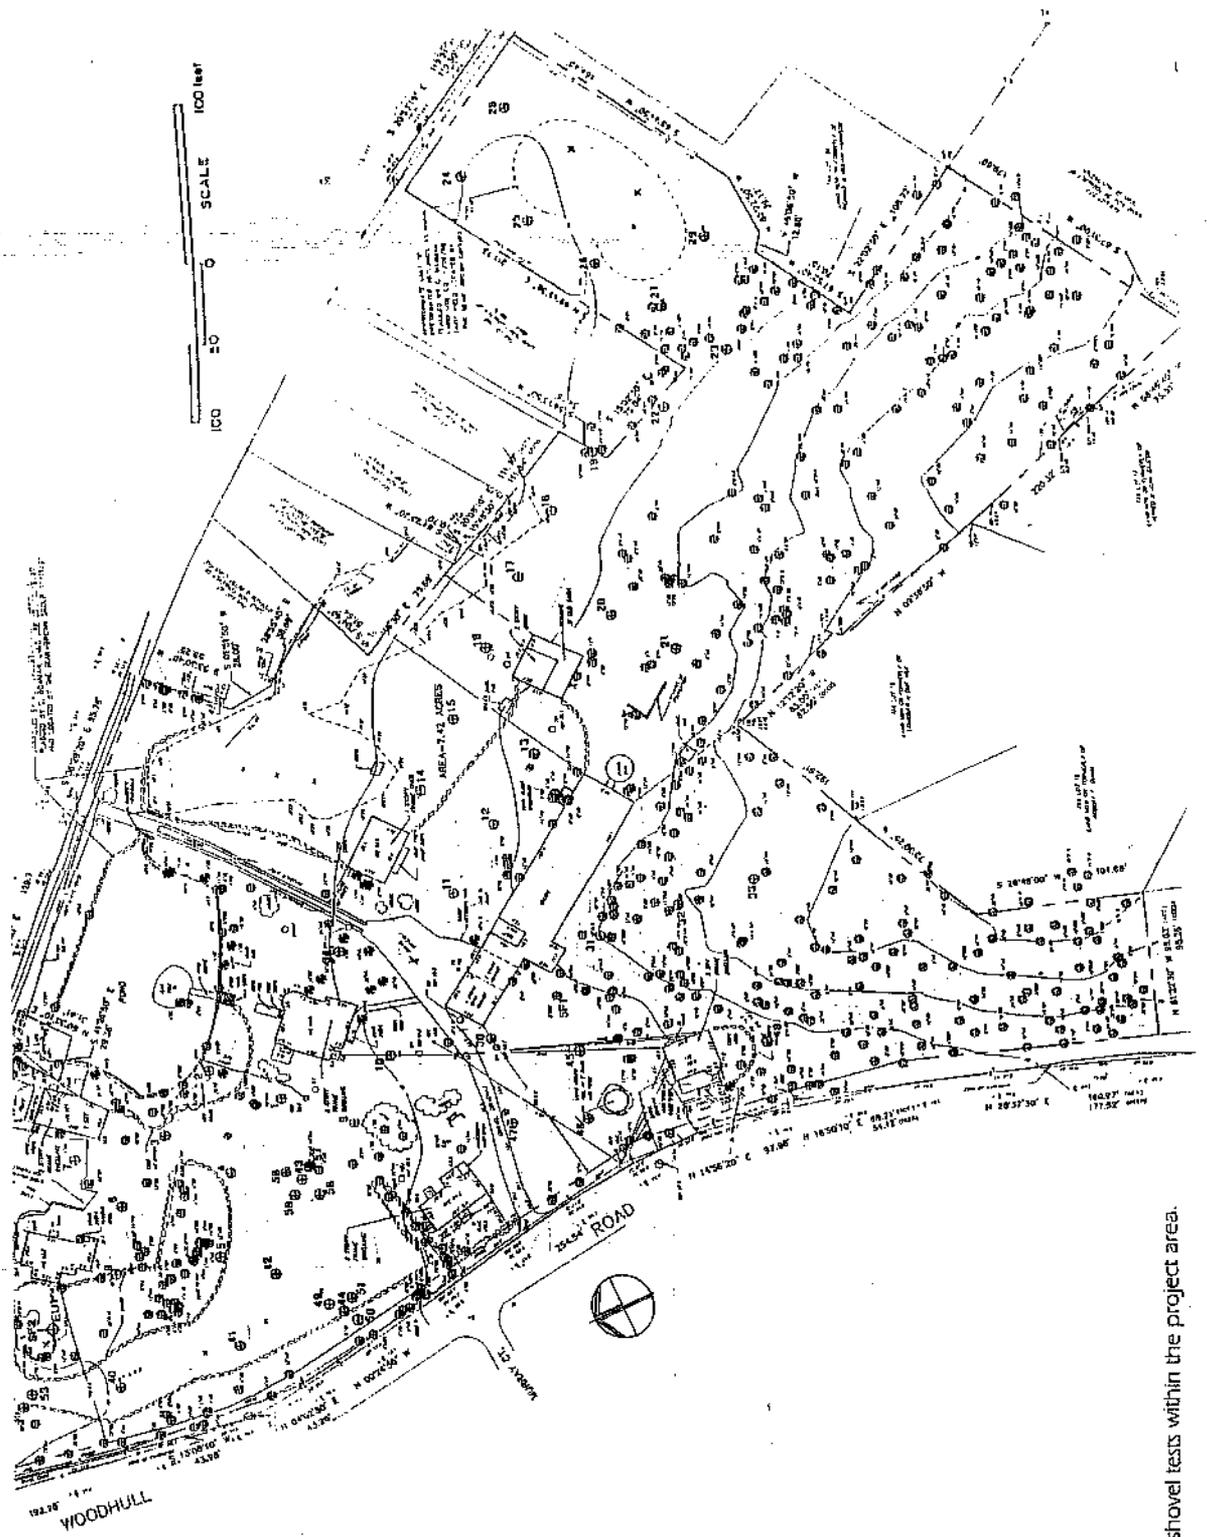
Figure 1: Locations of shovel tests within the project area.

The initial shovel testing and surface inspection resulted in the identification of five locations for more intensive investigation. These were shovel tests 36, 39, 43 and 49, and the location of the remains of a stone and mortar vat. Shovel Test 36 in the probable location of the Revolutionary War huts produced a fragment of bottle glass from a fill deposit. Two additional shovel tests were excavated ten feet from Shovel Test 36 to further investigate the fill deposit and search for possible eighteenth century remains. Shovel Test 39, located close to the probable Tannery location, produced shell fragments from a probable plowzone layer. Two additional shovel tests were excavated ten feet away from Shovel Test 39 to determine whether this deposit could
