TRAFFIC CALMING STUDY

Woodbury Road

From Main Street/State Route 25A to
West Pulaski Road/County Route 11

May 2015

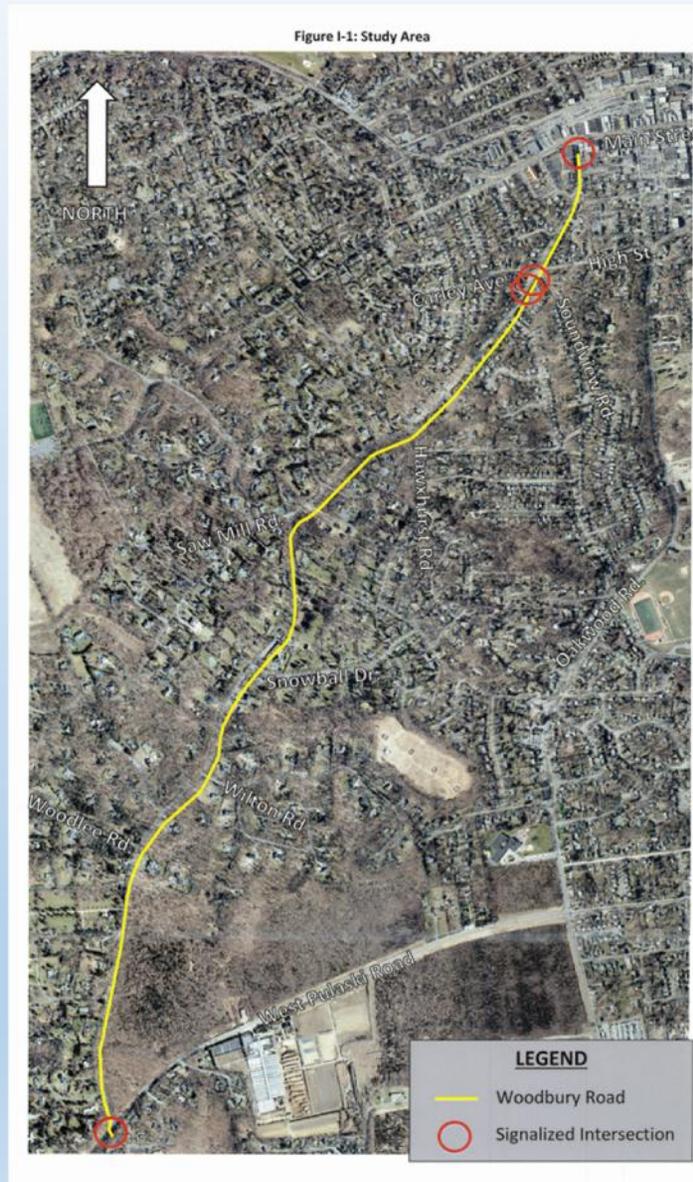
Woodbury Road Study Area

- Woodbury Road Description
 - North-South Collector
 - Posted Speed Limit is 30 MPH (20 MPH at St. Patrick's School)
 - Approximately 2.5 miles in length
 - Roadway width varies from 22' to 40' – lane widths are 10'-12'
 - Generally one lane in each direction
 - Sidewalks exist only at the north end of the study area
- Woodbury Road Intersection Traffic Controls
 - Traffic signals exist at Main Street, High Street/Soundview Rd/
Carley Avenue and at West Pulaski Road
 - Other intersecting side streets are controlled by STOP signs

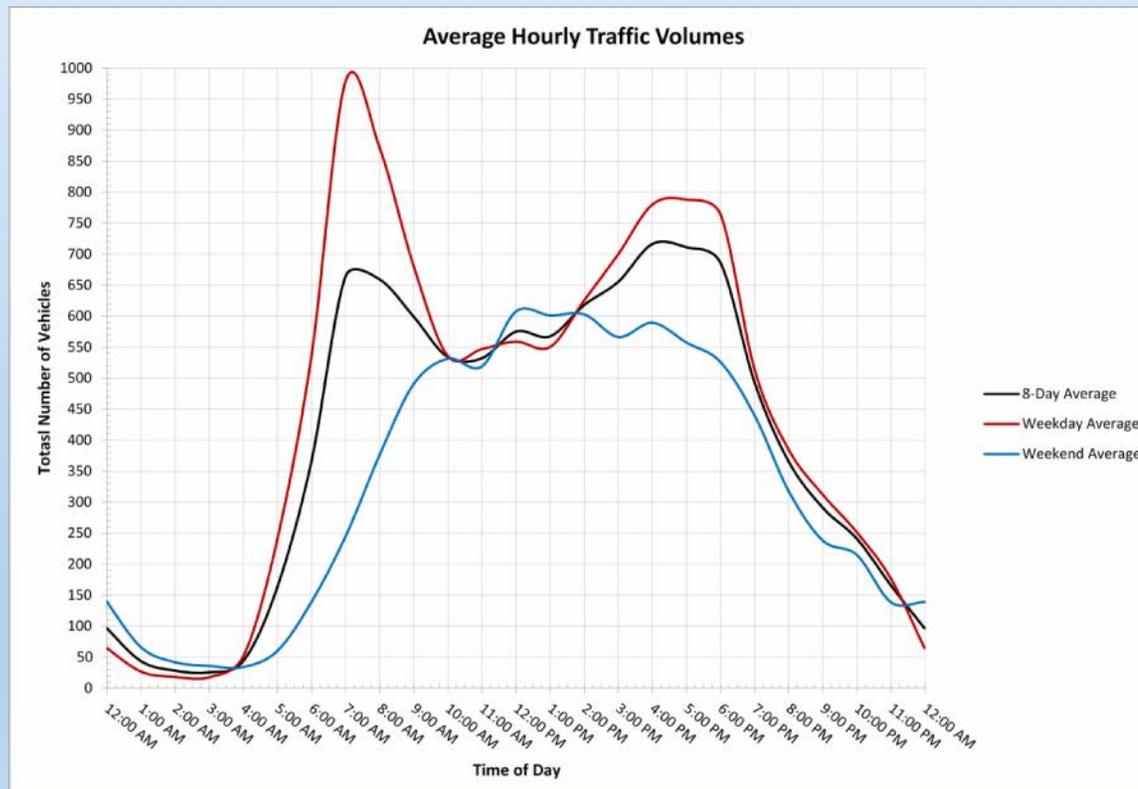
- Vehicular Traffic Volumes
 - Southbound peak 7AM – 8 AM, between 500 and 625 VPH
 - Northbound peak 6 PM – 7 PM, between 400 and 475 VPH
 - Midday directional flow is even at 250 VPH in each direction

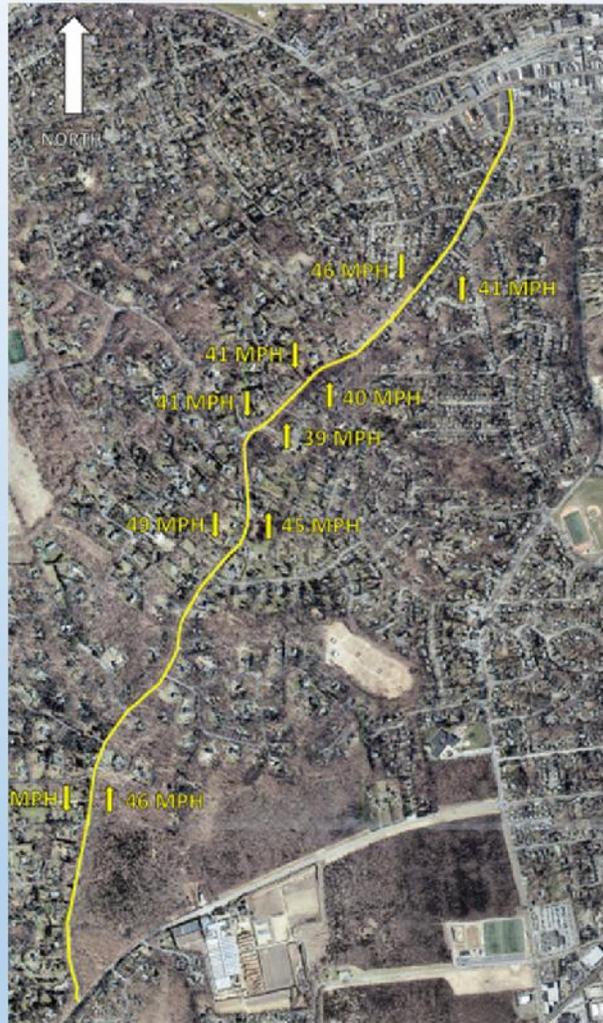
85th Percentile Speeds By Section

- Vehicular Speeds
 - 85th percentile speed is 44.3 MPH
 - Speeds varied by section as well as by time of day
 - Highest speeds observed between Saw Mill Road and Snowball Drive
 - Northbound – 85th percentile speed was observed at 45 MPH.
 - Southbound – 85th percentile speed was observed at 49 MPH

Location	Max Speed [MPH]		85 th Percentile [MPH]	
	NB	SB	NB	SB
South of Briarwood Dr.	76	76	41	46
Between Hawxhurst Rd. & Tall Tree Ct.	76	76	40	41
Between Tall Tree Ct. & Saw Mill Rd.	55	60	39	41
Between Saw Mill Rd. & Snowball Dr.	76	76	45	49
South of Woodlee Rd.	60	75	46	47
Total	76		44.3

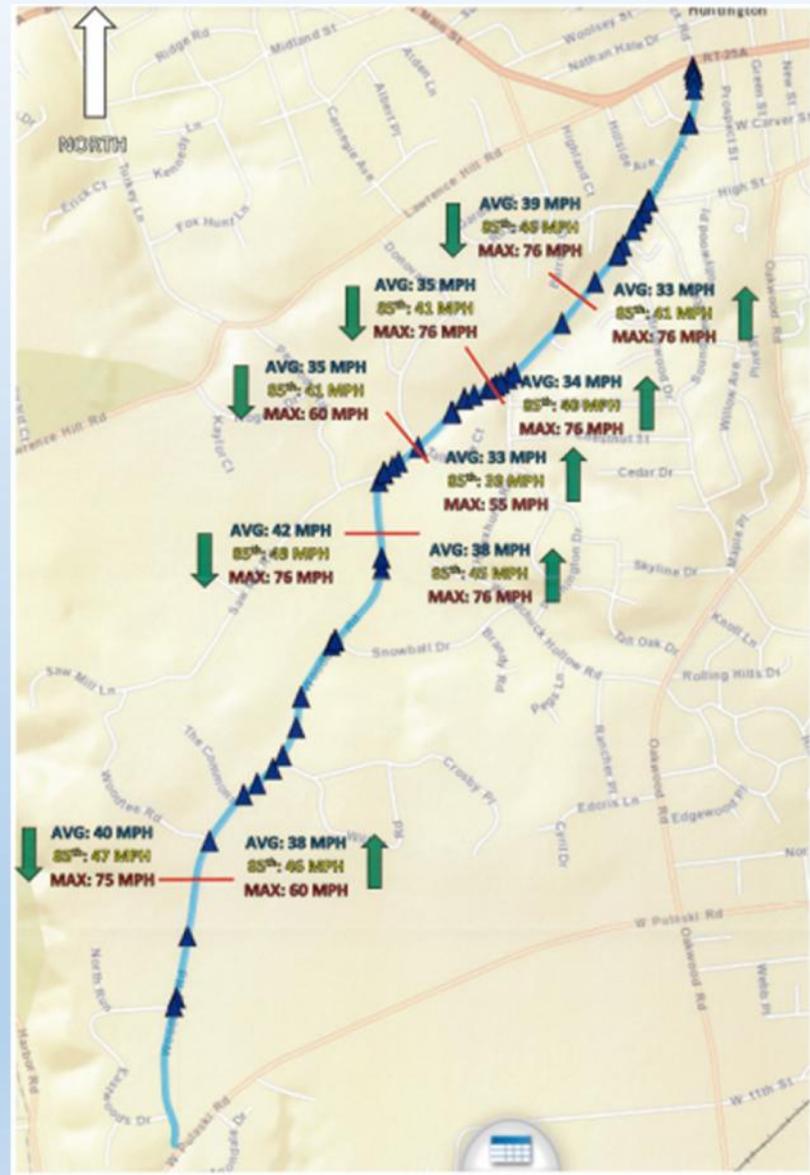
Graphic Correlating Vehicular Speed with Crash Frequency

- Crash Analysis
 - Roadway Factors
 - 7 crashes (11%) occurred at signalized intersections;
 - 3 of these were rear-end crashes
 - 22 crashes occurred at non-signalized intersections;
 - 7 of these were rear-end crashes, 3 were right-angle.
 - 35 crashes (54.7%) took place on curved sections of road.
 - 13 involved fixed objects; 10 during inclement weather.
 - 5 crashes were of the rear-end type, 2 in inclement weather.
 - 3 crashes involved overtaking, 1 in inclement weather

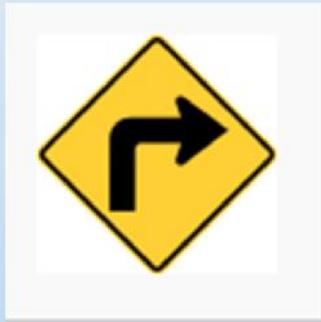
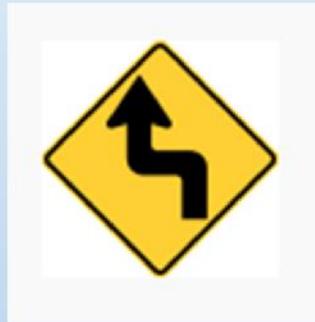
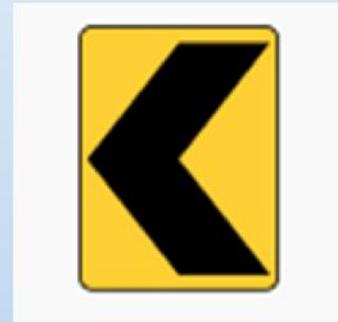
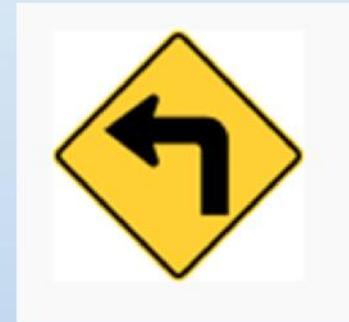
- Upgrade Existing System of Warning Signs

- Based on the MUTCD – Curve Warning Signs to be Upgraded to Turn Signs
- Increase the Turn Warning Sign Size from 30" to 36"
- Increase the Chevron Sign Size from 24"x 30" to 30" x 36"
- Increase the Speed Advisory Plaque Size from 24" to 30"
- Install Additional Warning Signs Where Warranted
- Upgrade the reflective material to Diamond Grade
- Install Diamond Grade Reflective Inserts onto the Channel Posts

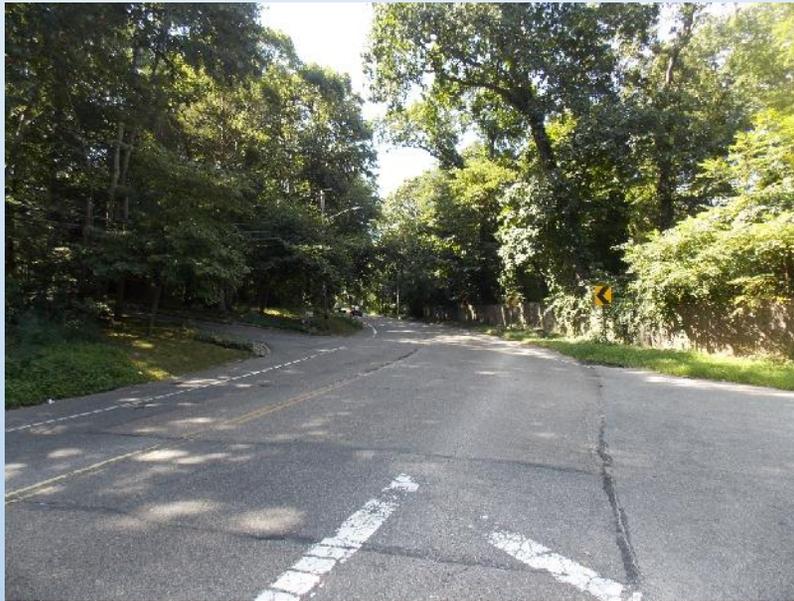
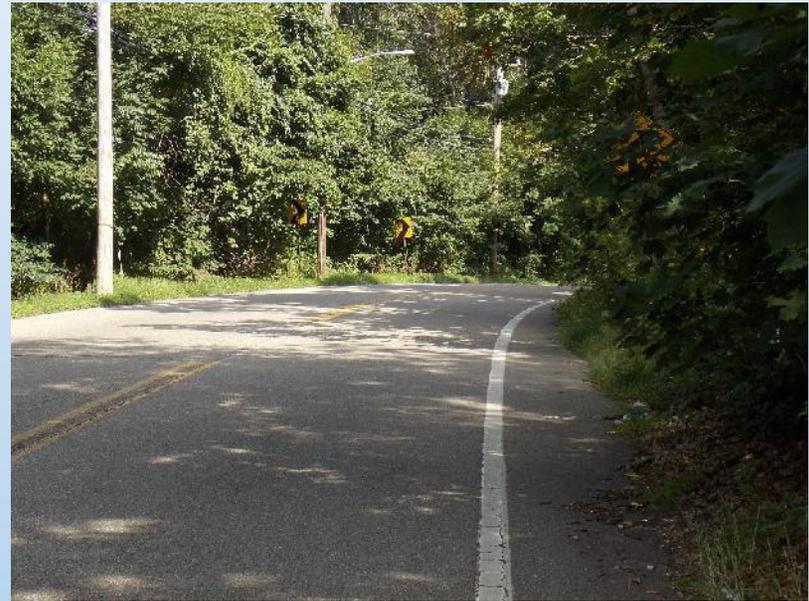
Upgrade Existing Yellow Centerlines and White Edgelines

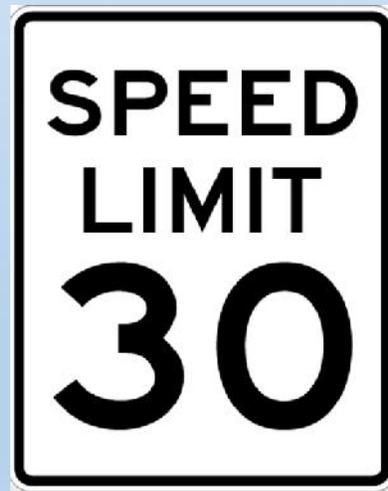
- Speed Reduction Strategies
 - Upgrade the Existing 30 MPH Speed Limit signs utilizing Diamond Grade Reflective Sheeting

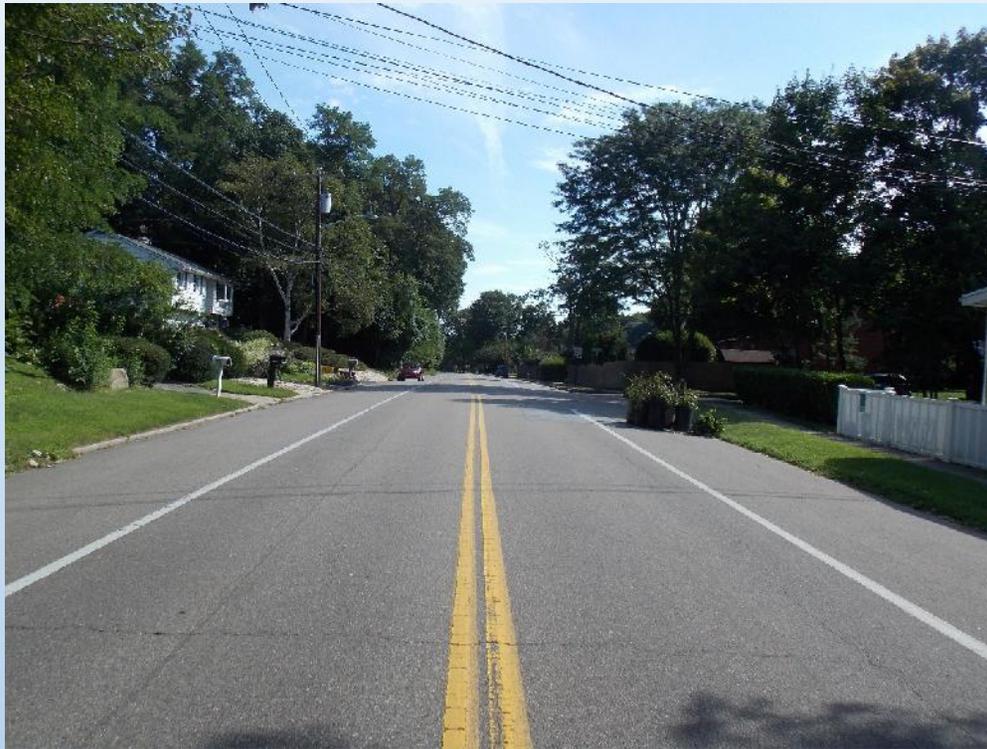
Reduce Lane Width to a Uniform 10' Wherever Practical

Install Centerline Rumble Strips in Areas Away from Residences

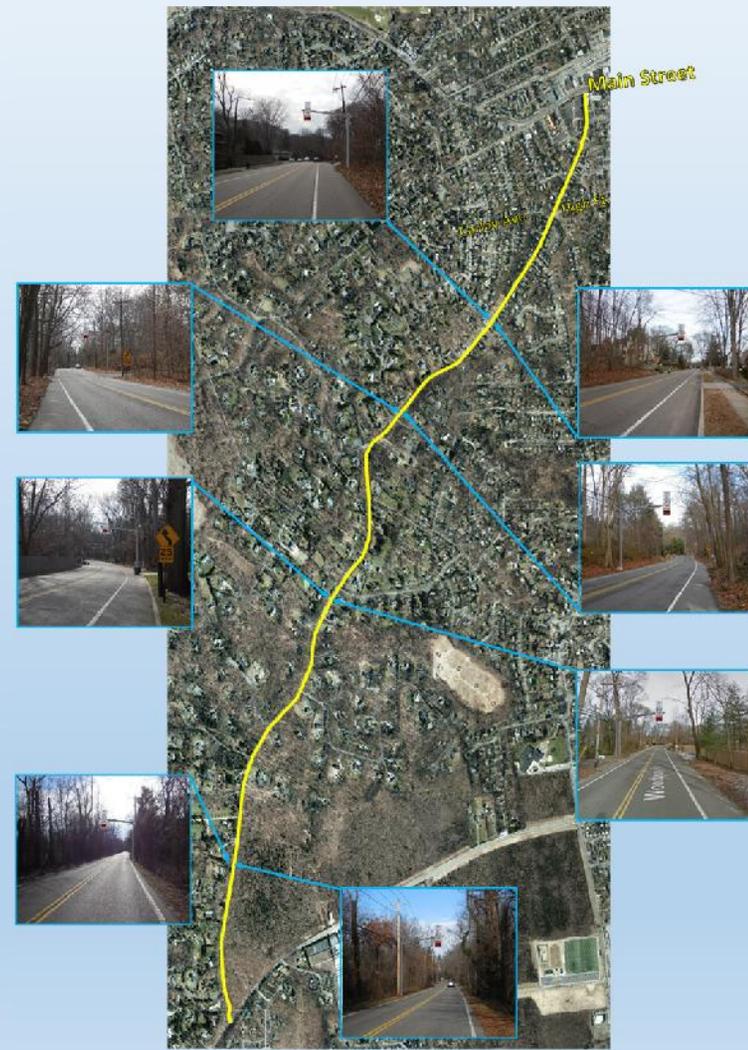
Proposed Speed Awareness Device Locations

- Between Woodley Road and East Woods Drive
- South of Snowball Drive
- North of Tall Tree Court
- South of Carley Avenue

- South of Carley Avenue
- North of Tall Tree Court
- South of Snowball Drive
- Between Woodley Road and East Woods Drive

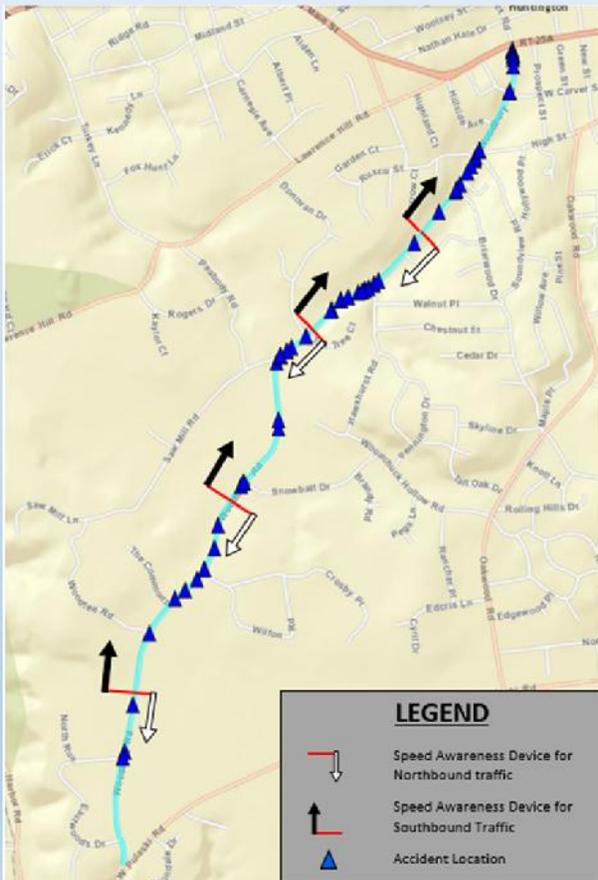
Figure III-3: Proposed Speed Awareness Device & Accident Locations

Proposed Speed Awareness Device Installations
with Crash Locations

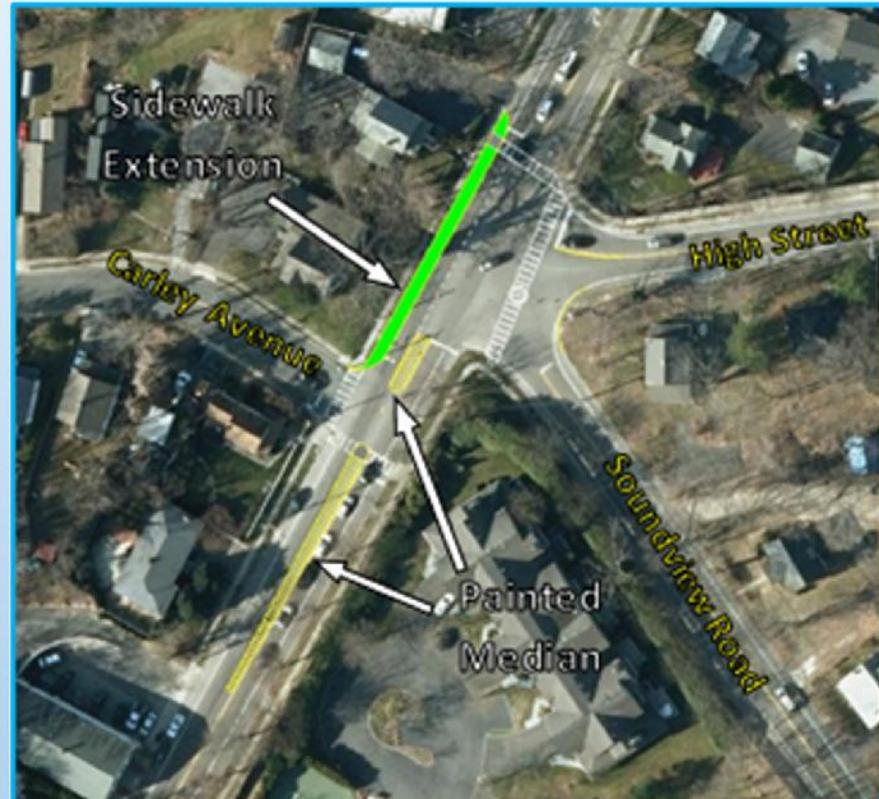
Woodbury Rd at Soundview Road, High Street and Carley Avenue

- Install painted center medians on the approaches to the intersection to properly align the through lanes.
- Widen the west sidewalk in order to reduce the travelled way and prevent overtaking.
- Re-evaluate the traffic signal timing to improve efficiency and safety.
