TOWN OF HUNTINGTON LONG ISLAND, NEW YORK BEACH EROSION STUDY REPORT

AUGUST 30, 2006
OCC PROJECT # 205073

EXECUTIVE SUMMARY

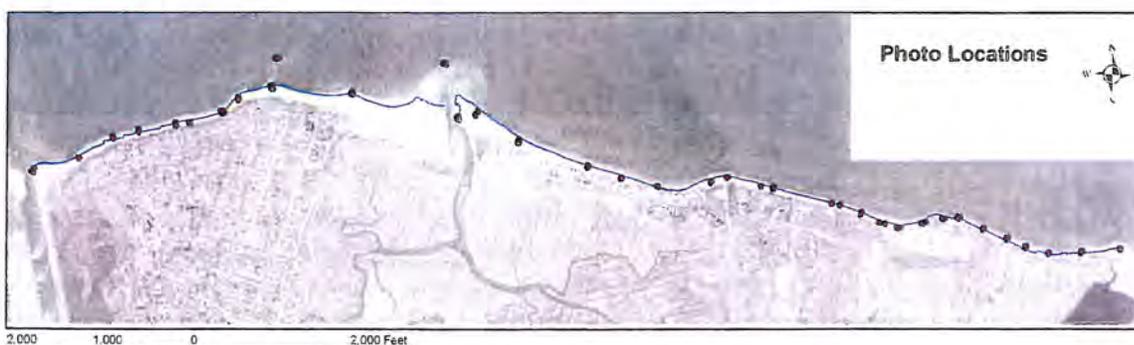
Figure 3.0-1: Map of photo locations.

To document the specifics of the site, geo-referenced land based photos were taken at representative locations (Figure 3.0-1) using the GPS and picture direction (heading). They constitute an important data source for regulatory review, planning, and disaster and historic documentation. These photos, locations, and directions and notes are provided in Appendix A and in electronic format in Appendix D.

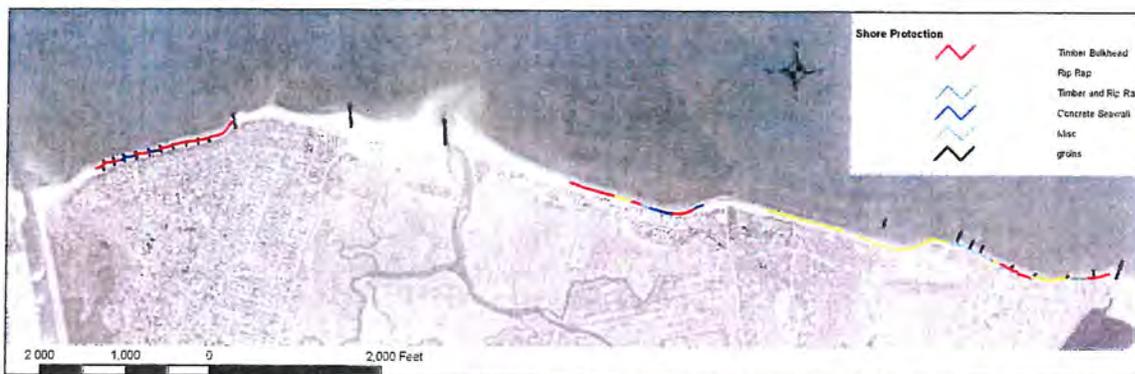
Figure 4.1-1: Types and locations of bluff and shoreline structures in the study area.

There are multiple forms of shoreline and bluff protection present in the study area (Figure 4.1-1). The most common are timber bulkheads (vertical) (Photo 4.1-1) and/or riprap revetments (Photo 4.1-2) (22 percent and 21 percent, respectively). Groins (Photo 4.1-3) are also prevalent in the western and eastern portions of the study area; many of the groins have been in place since the 1940's. A substantial portion in the middle of the study area (from Crab Meadow Beach to the west end of Makamah Beach) has no shoreline or bluff protection structures (45 percent; Photo 4.1-4). The remaining shoreline (12 percent) has a variety of miscellaneous shore protection structures (Photos 4.1-5 and 4.1-6), including large diameter circular culverts placed upright along the eastern portion of Indian Hills Golf Course (4.1-1).

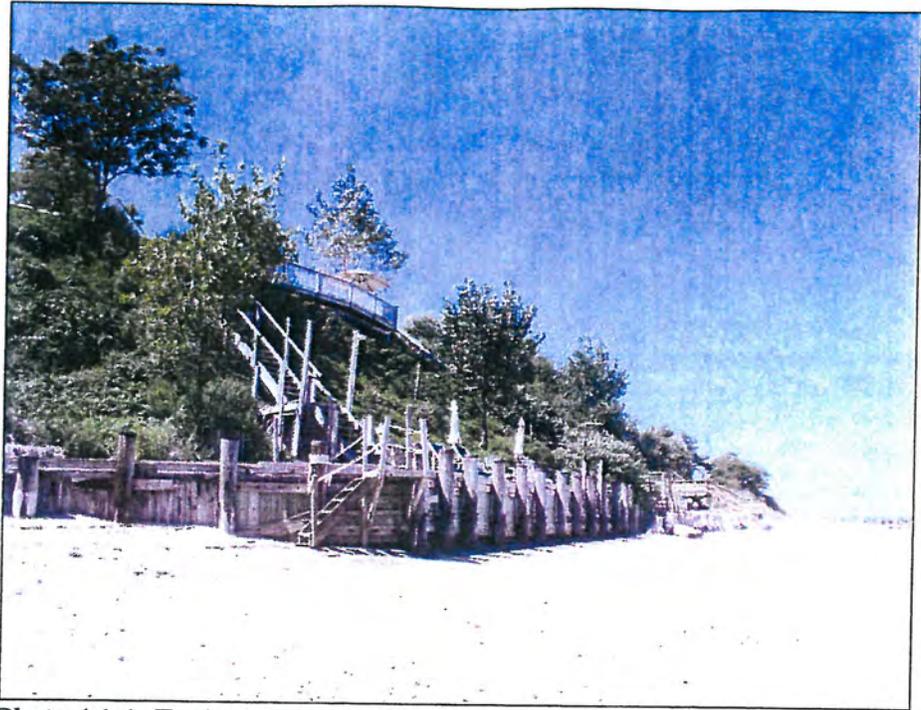
Photo 4.1-1: Typical timber bulkhead protected shoreline.

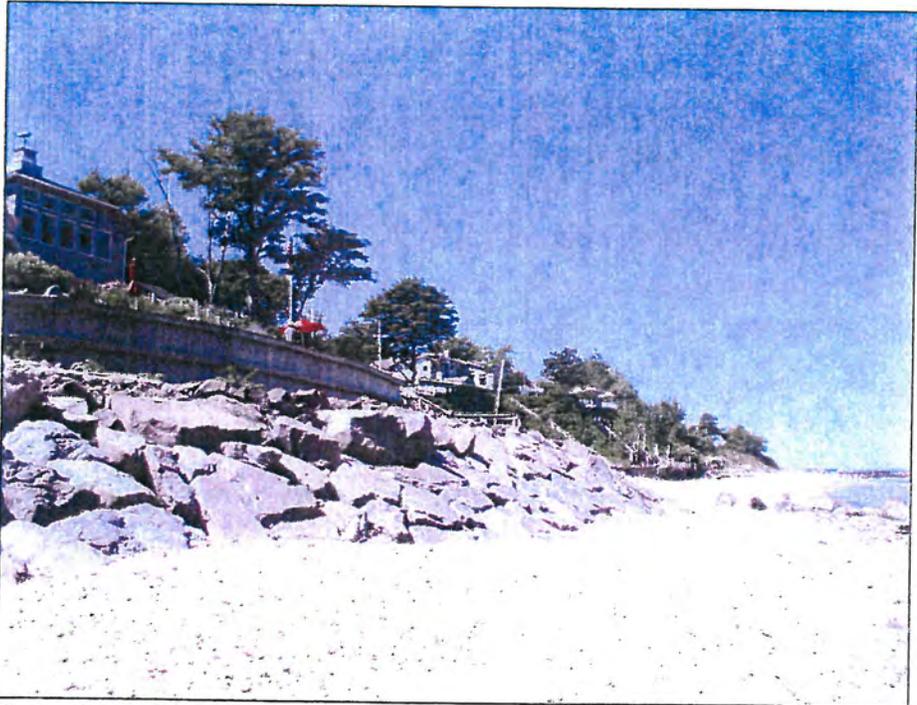
Photo 4.1-2: Riprap revetment.

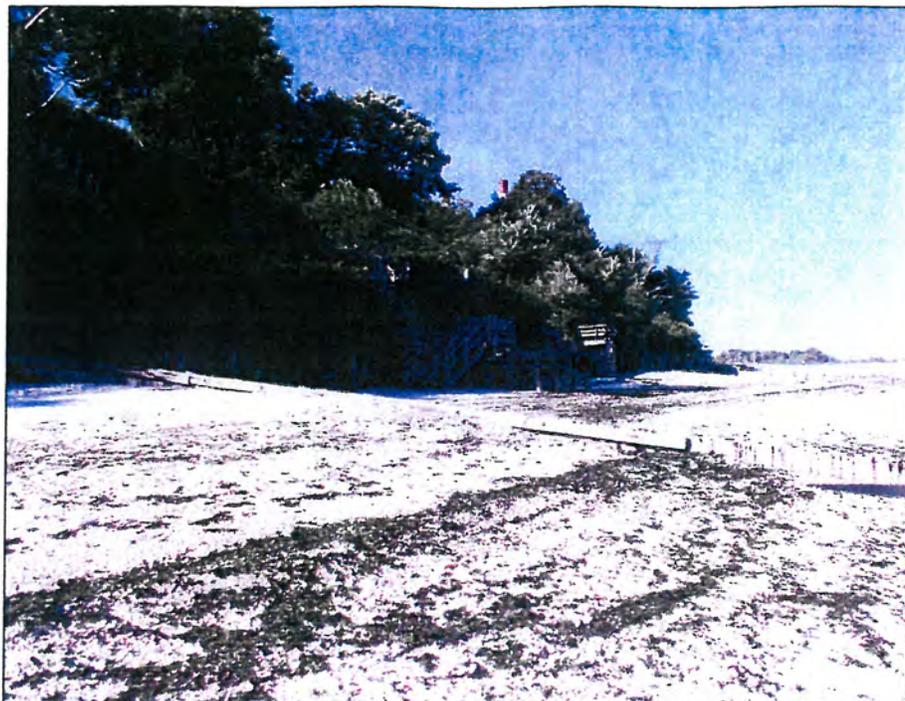
Photo 4.1-3: Typical wooden groin on western section of study area.

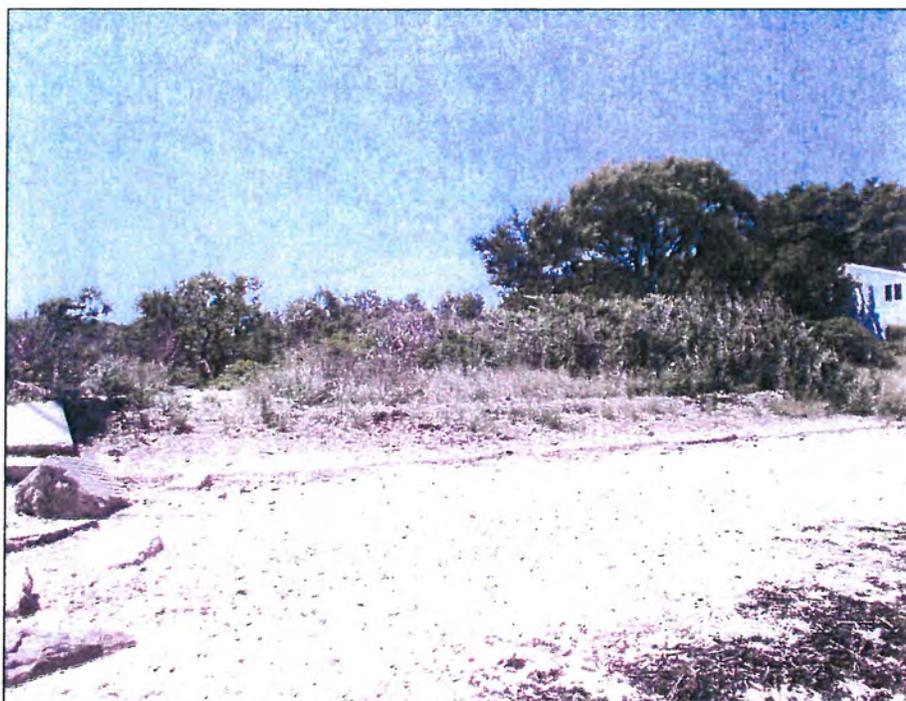
Photo 4.1-4: Natural shoreline.

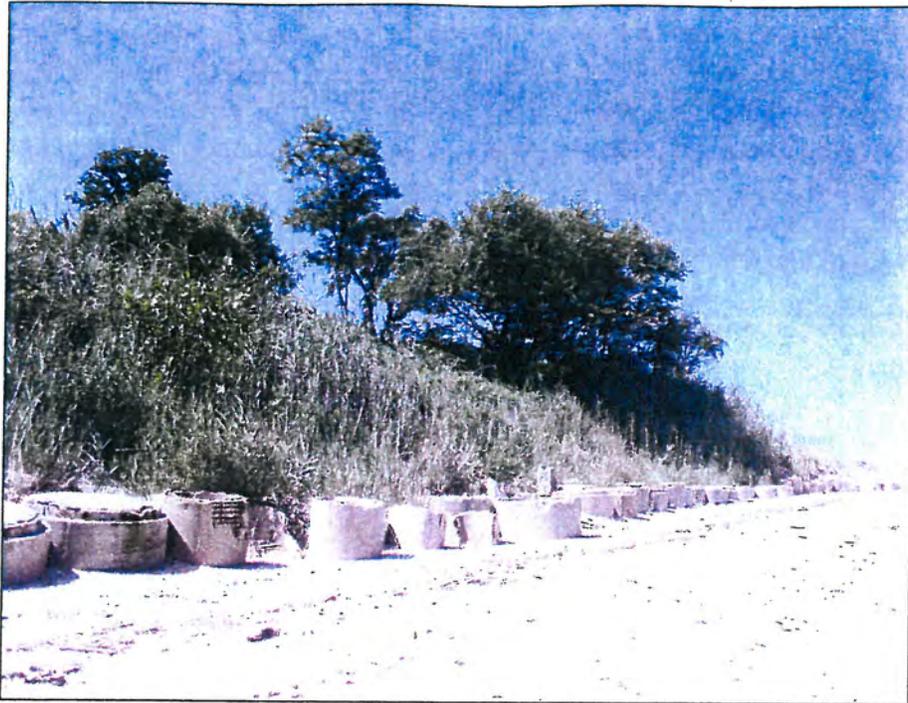
Photo 4.1-5: Miscellaneous (upturned culverts) shore protection east of Indian Hills Golf Course

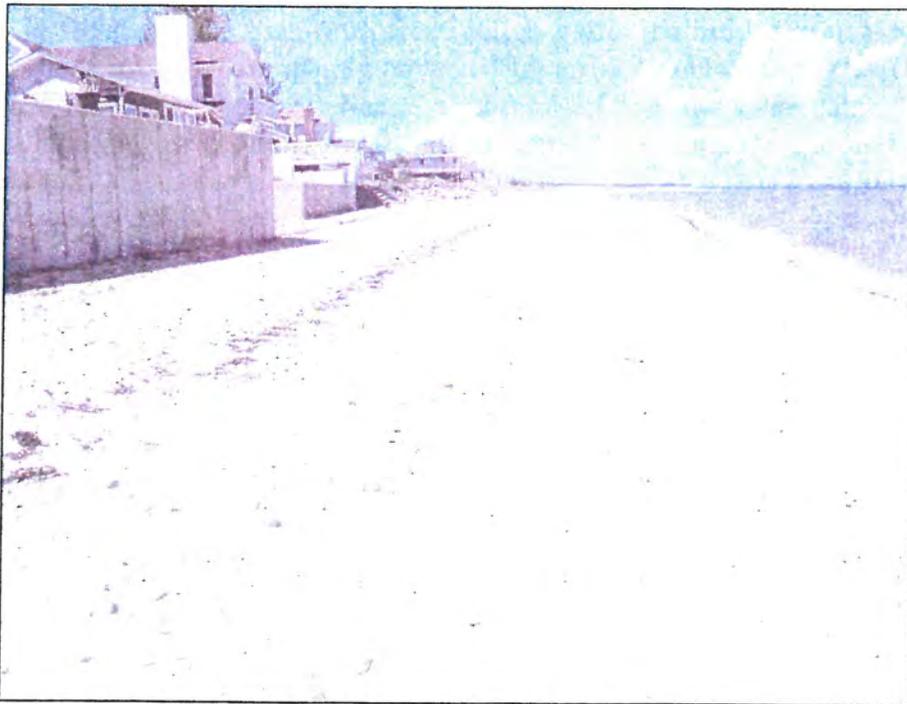
Photo 4.1-6: Concrete seawalls on Makamah Beach.

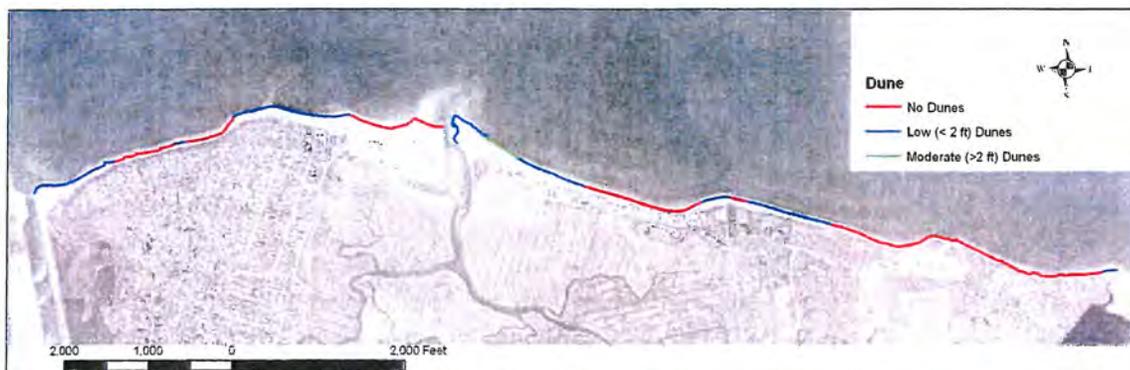
Figure 4.1-2: Map of dunes location and relative size along the study area.

Dunes and bluffs are prevalent along the study area as well as along the North Shore of Long Island. Erosion of bluffs contributes sand to the system allowing dunes to form and provide substrate for dune grasses such as American and Panic beach grasses (*Ammophila breviligulata* and *Panicum amarum*), which helps to stabilize the sediment. The dunes, in-turn, protect bluffs from moderate wave conditions. Areas without dunes (where once existing) indicate a negative sediment balance (Coates et al., 2000) (Figure 4.1-2). About 55 percent of the study area does not have dunes; the remaining (45 percent) has mainly small (less than 2 feet high) dunes.

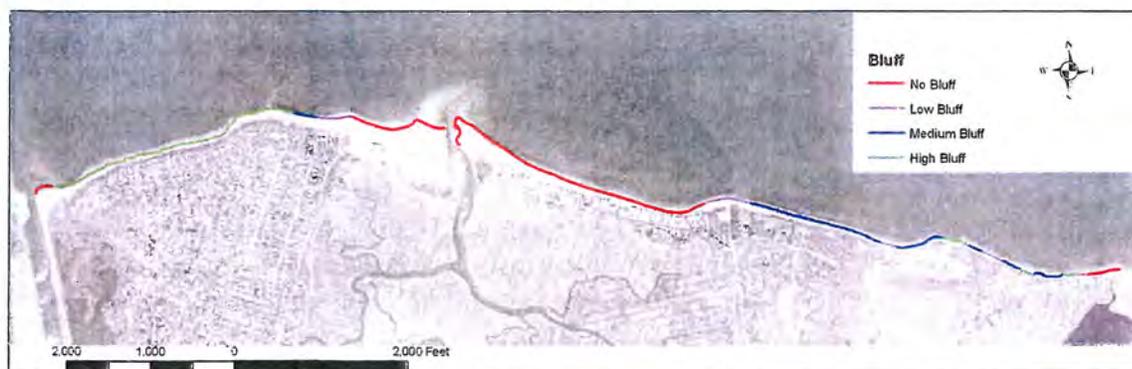
Figure 4.1-3: Map of relative bluff heights.

Bluffs in the study area were categorized based on relative heights (Figure 4.1-3). Bluff heights in the study area are typically lower than 40 feet (USACE, 1969). Four categories of bluff heights were defined based on heights estimated during field work: none, low (0 to 15 feet), moderate (15 to 30 feet), and high (30+ feet). High bluffs are most common on the western portion of the study area and are mainly protected by erosion control structures (Figure 4.1-1). Moderate sized bluffs on the central-eastern portion of the study are largely unprotected. Moderate and high bluffed shorelines make-up 51 percent the study area, areas with no bluffs, mainly in the center of the study area, comprise 39 percent, and the remaining 10 percent of the study area is characterized by low bluffs.

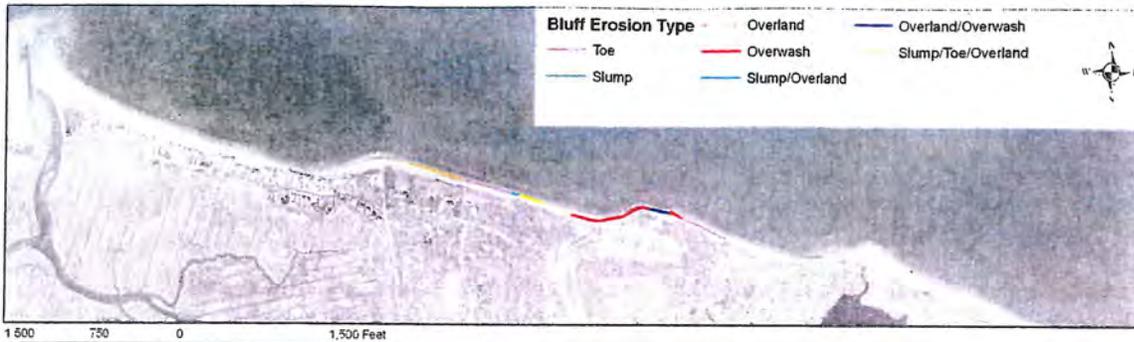
Figure 4.1-4: Areas and types of active bluff erosion noted in the field.

(behind revetments or bulkheads). In general the entire western portion of the study area had stable bluffs; a result of bluff stabilization and/or bulkheads and wide beaches. In the eastern portion, there are areas of active bluff erosion (Figure 4.1-4).

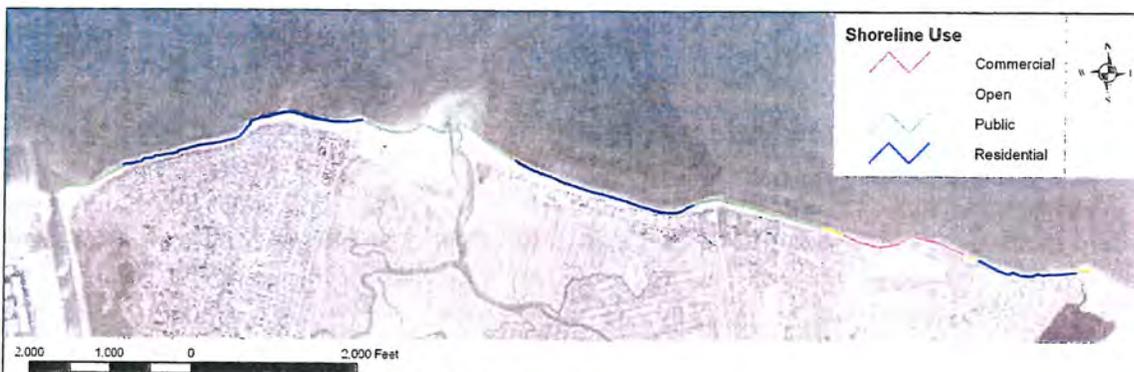
Figure 4.1-5: Shoreline upland development.

Coastal development types defined for this study included public, commercial, residential, and undeveloped or open. Of the entire shoreline (14,500 feet) about 50 percent is residential, 35 percent is public, 12 percent is commercial (Indian Hills Golf Course), and 3 percent is undeveloped residential (Figure 4.1-5).

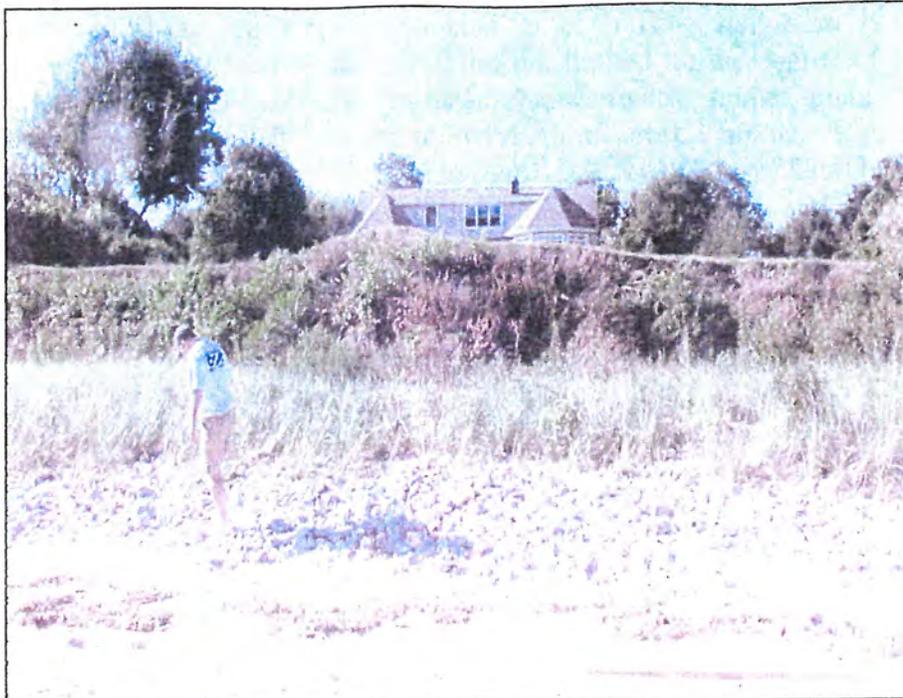
Photo 4.1-8: Low-profile stone toe protection.

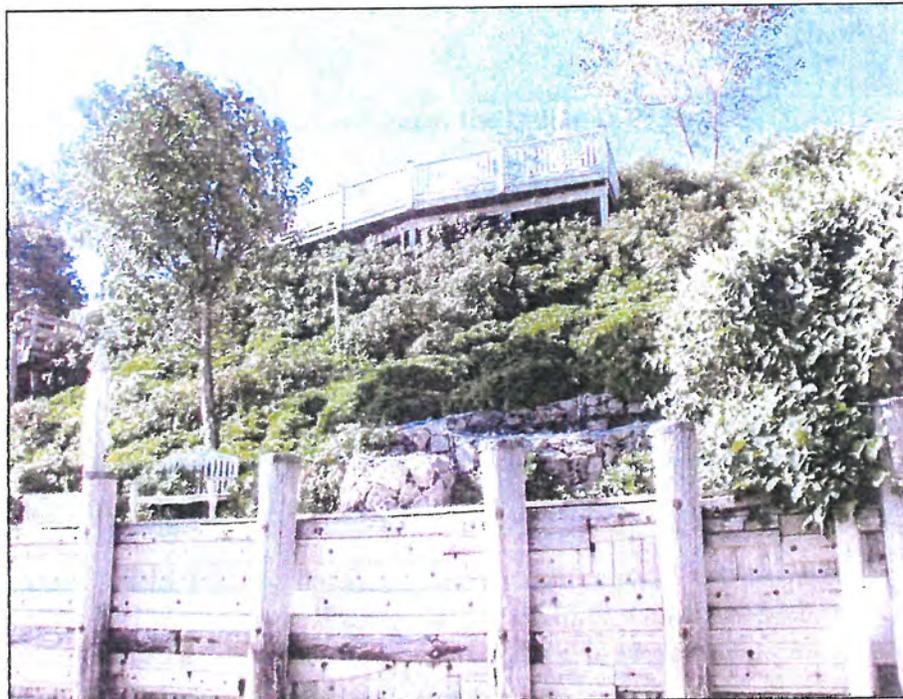
In contrast, many shorefront residents have taken more elaborate measures to landscape the bluff face and have constructed bulkheads and sea walls, as evident in Photo 4.1-9. In these cases, horticultural specimens and hybrid plant varieties have been installed, often in conjunction with small timber terraces or masonry retaining walls for additional slope stabilization.

Photo 4.1-9: Timber bulkhead and landscaped bluff.

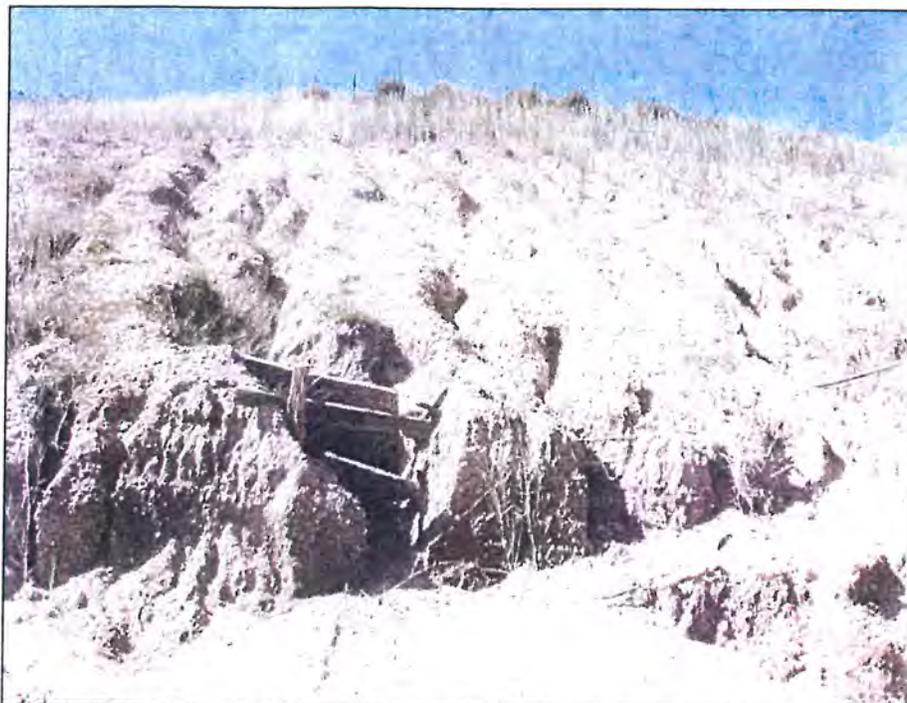
Photo 4.1-10: Severe bluff erosion at the Indian Hills area.

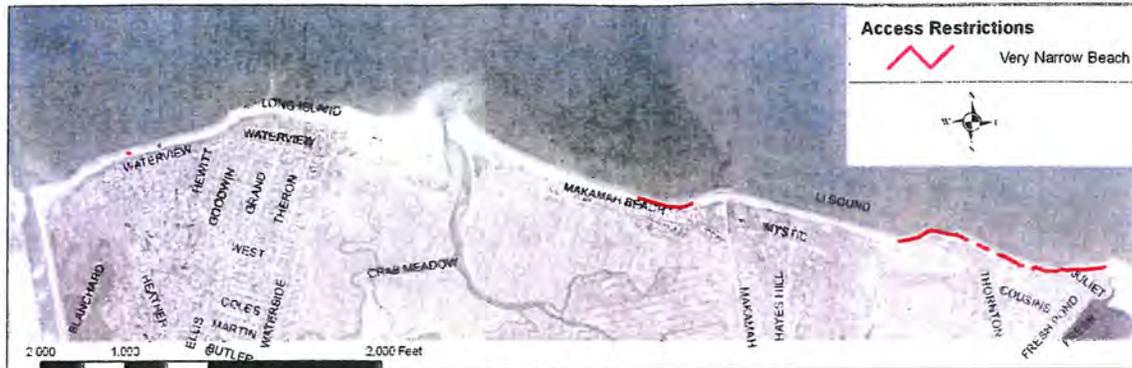
Figure 4.1-6: Areas that may impede the public access to the shoreline.

end of Makamah Road. In order to reach the western public beach, the public must cross the narrow beach at the east end of Makamah Beach.

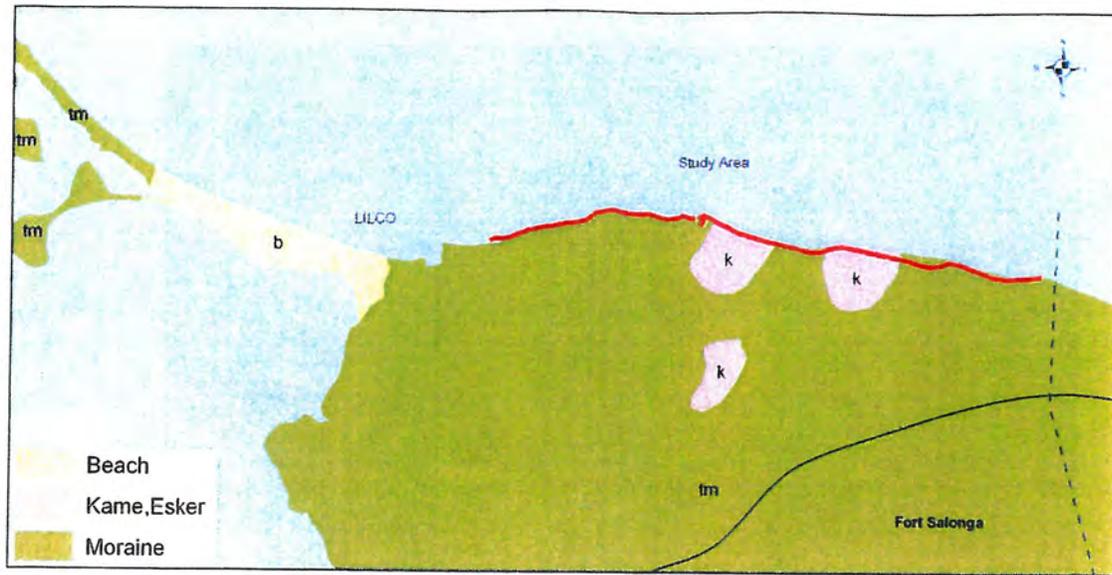
The surface geologic map (NY Geological Survey) shows that the area is dominated by till and moraine deposits (tm) and with pockets of kame (k) or melt-water features such as eskers (see Photo 4.2-1). In addition, there are exposed outcrops of Cretaceous sediments in the area around Indian Hills Golf Course (see Photo 4.2-2). The surface geologic units, to a large degree, define the shallow hydrology; melt-water features have high permeability and Cretaceous clays have almost none (aquiclude). Till and moraine units have varying levels of permeability depending on location.

Figure 4.2-1: Surface geology in study area; terminal moraine (tm), kame (k), and beach (b) deposits dominate the surface features.

Over the long-term, the highest or most severely eroding bluffs are concentrated in the eastern portion of the study area and correspond to the area known as the Broken Ground (Figure 5.3-1) and also to the area with melt-water glacial deposits, such as the west end of Geissler's Beach (Figure 4.2-1).

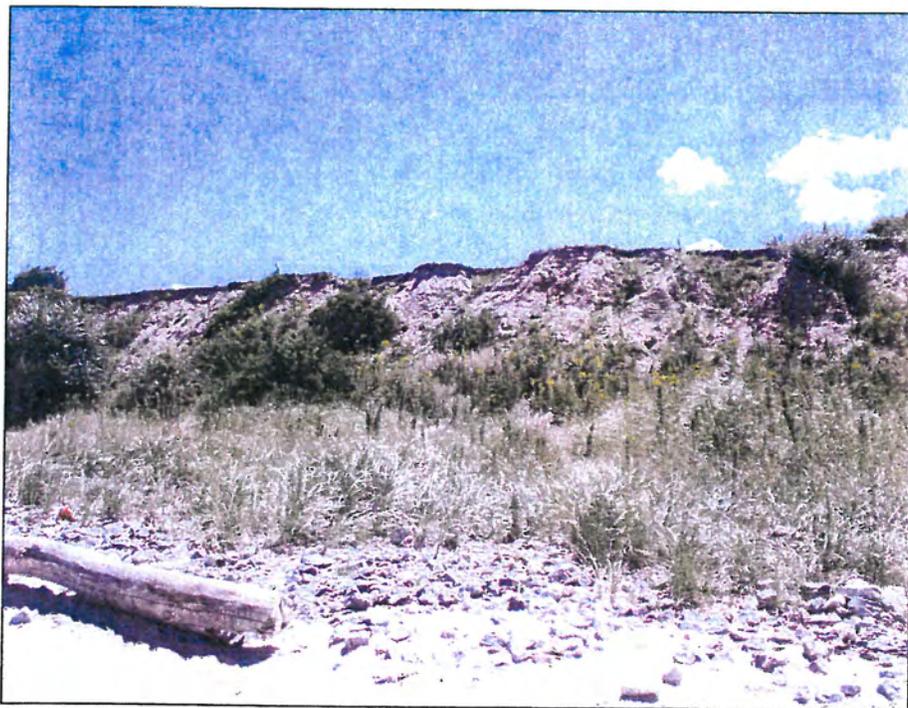
Photo 4.2-1: Bluffs in area of melt-water (k) deposits adjacent to Geissler's Beach.

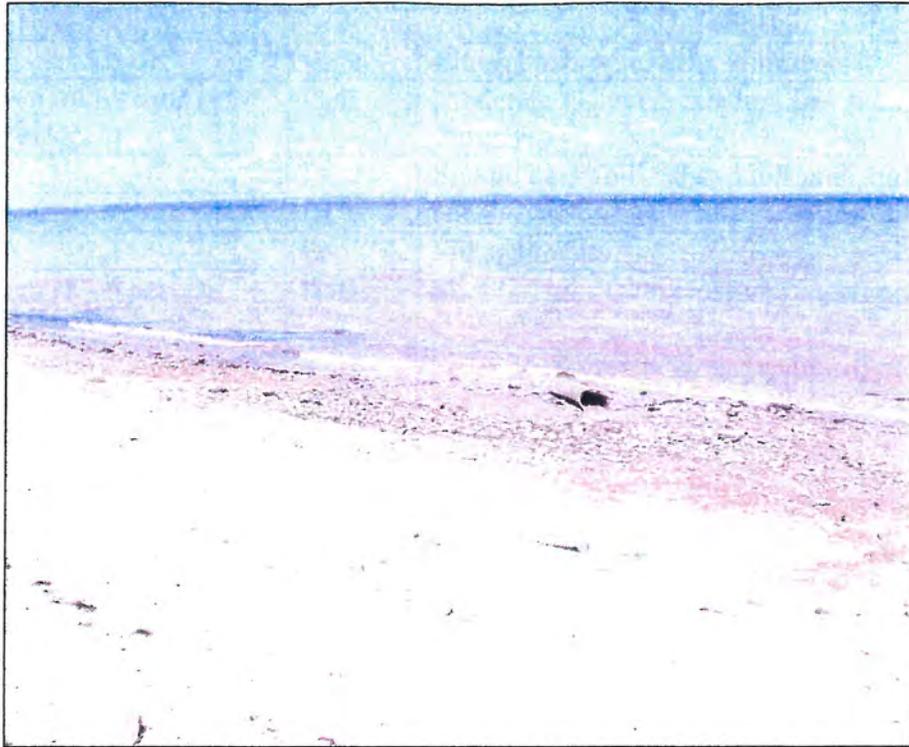
Photo 4.2-2: Brownish orange colored Cretaceous clay outcrops offshore (north) of Indian Hills Golf Course.

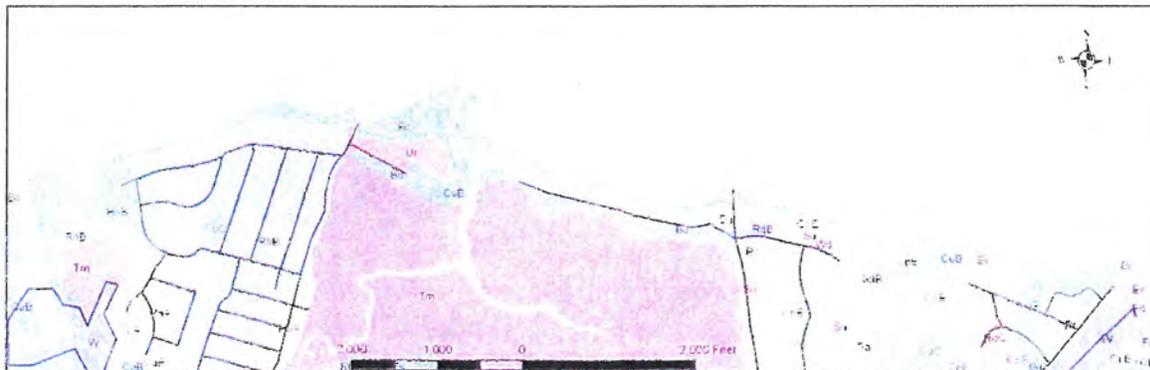
There are multiple soil types that have been mapped (NRCS, 2005) in the study area (Figure 4.2-2). Based on field observations, the mapped soil type appears to correlate with the general condition and aspect of the bluffs as well as the geologic surface units. Implementation of vegetative solutions is dependent on the type of soil present. Additionally, soil type has a bearing on the stability of the bluffs (Table 4.2-1).

Figure 4.2-2: Map of soil types in the study area; see Table 4.2.1 for soil type descriptions.

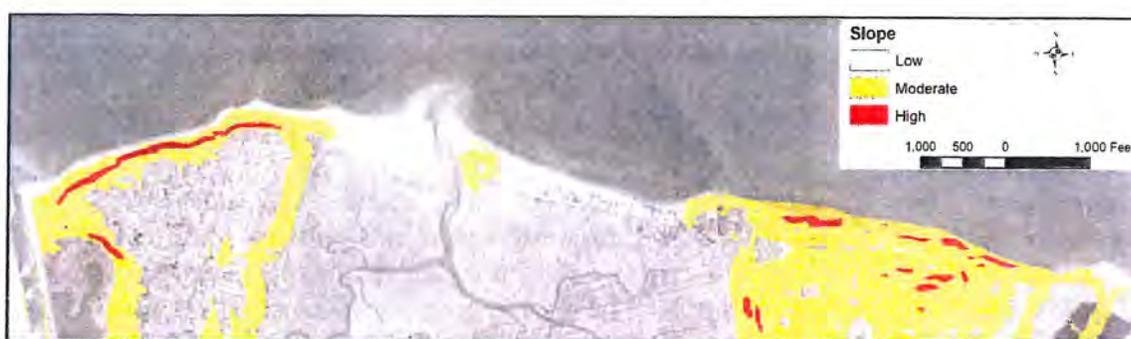
Figure 4.2-3: Map of relative slope.

Elevation data was sourced from the National Map (USGS); the 1/3 arc second (30 meter spacings) data, is the best available data. Although not accurate enough for detailed spot elevation analysis it does provide an overall estimate of areas with high slopes (Figure 4.2-3). The combination of high slopes, soil types, and underlying geology provides important baseline management data. The highest slopes (greater than 30 percent), quite predictably, correspond with the highest bluff areas and are dominant on the western third of the study area.

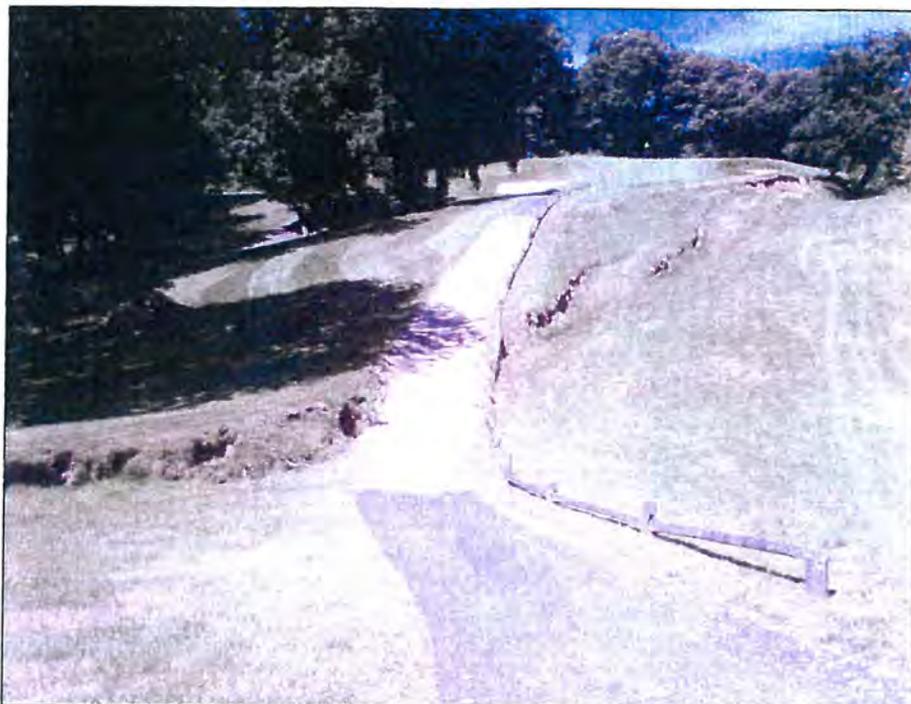
Since 2002 there has been additional differential soil movement along the scarp. Several areas along the scarp have developed near vertical faces and substantial depressions that channel water into the failure plane. Visual inspection, discussions with golf course staff and review of photographs indicates that vertical movement of up to 4 feet has occurred since 2002 (see Photo 4.2-3). While the work completed in 2002 has reduced erosion of the bluff toe it has not eliminated soil movement along the underlying failure plane.

Photo 4.2-3: Soil failure plane and vertical scarp at Indian Hills Golf Course.

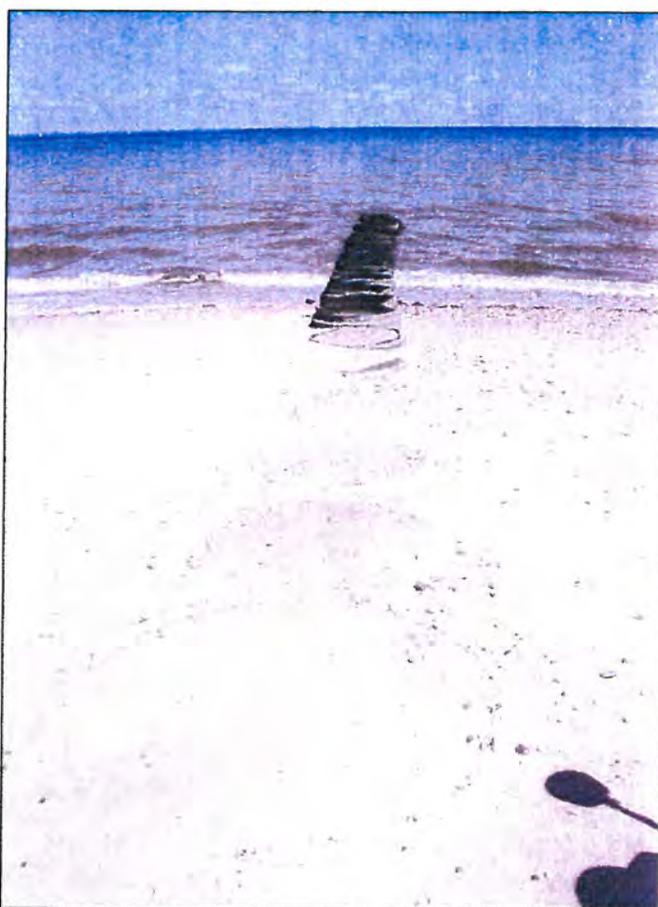
Photo 4.3-1: Groin on eastern portion of study area (note possible accumulation of sediment on the west (left) side of the groin, possibly indicating seasonal eastward littoral drift).

Longshore transport of littoral sediment has been quantitatively estimated in previous reports (LILCO, 1977) between 3,000 and 6,000 cubic yards per year to the west. Based on field observations most of the area appeared to have westerly directed longshore transport; however, on the eastern end of the study area between Indian Hills Golf Course and the Smithtown line (Figure 1.0-2) there were areas that appeared to have localized eastward directed longshore transport. This is not uncommon given that during the summer months southwest winds dominate, but it was not noted in other areas. It may indicate that net transport rates are lower on the eastern portion of the study area than on the western portions.

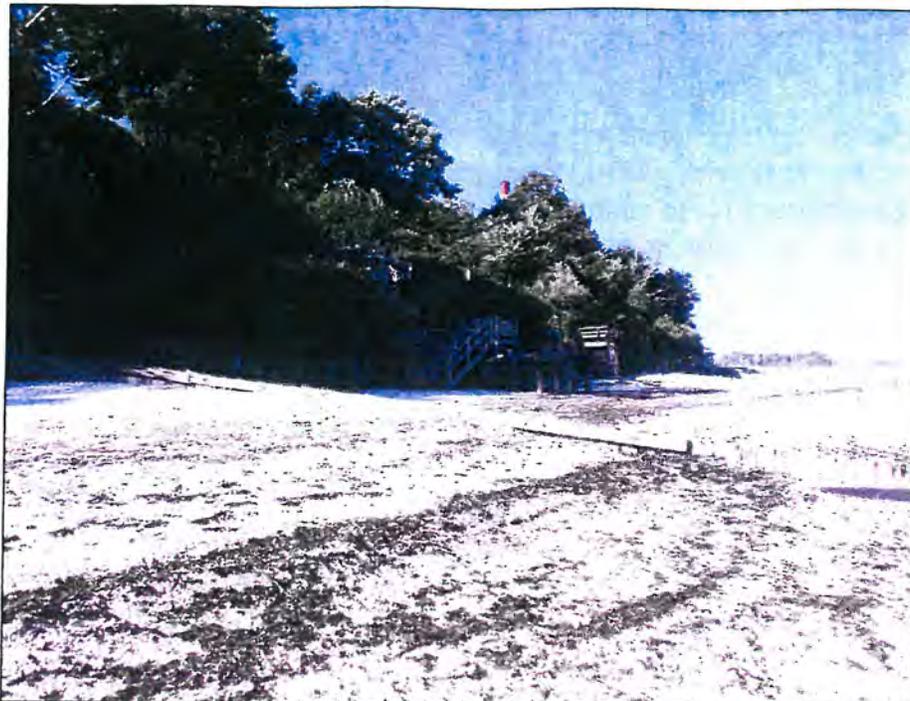
Photo 4.3-2: Groin on western portion of study area with elevation difference from east to west.

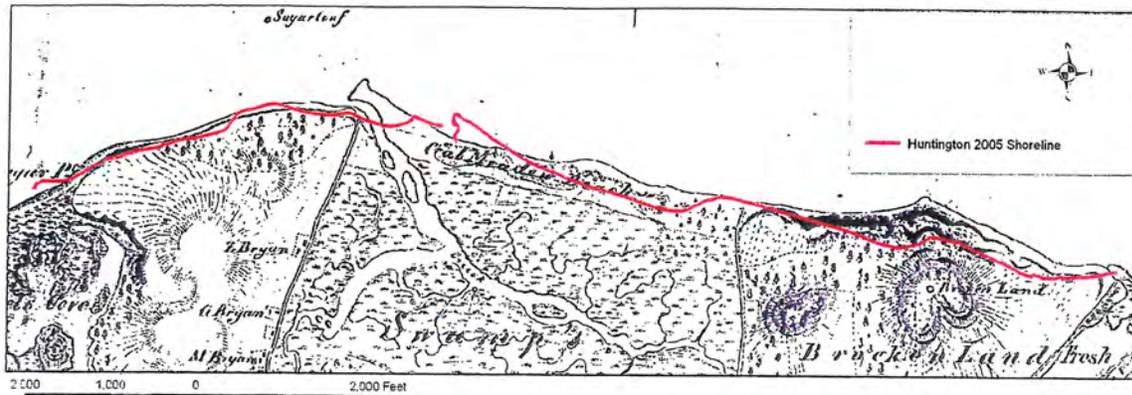
Another notable change is the relocation of the tidal channel (inlet) feeding Crab Meadow marsh; this highlights the inherent dynamic nature of the barrier spit. The jetty that was built along the inlet (early 1900's) has essentially stabilized the inlet location and no future change is expected.

Figure 5.3-1: Present shoreline overlaid on georectified 1837 map.

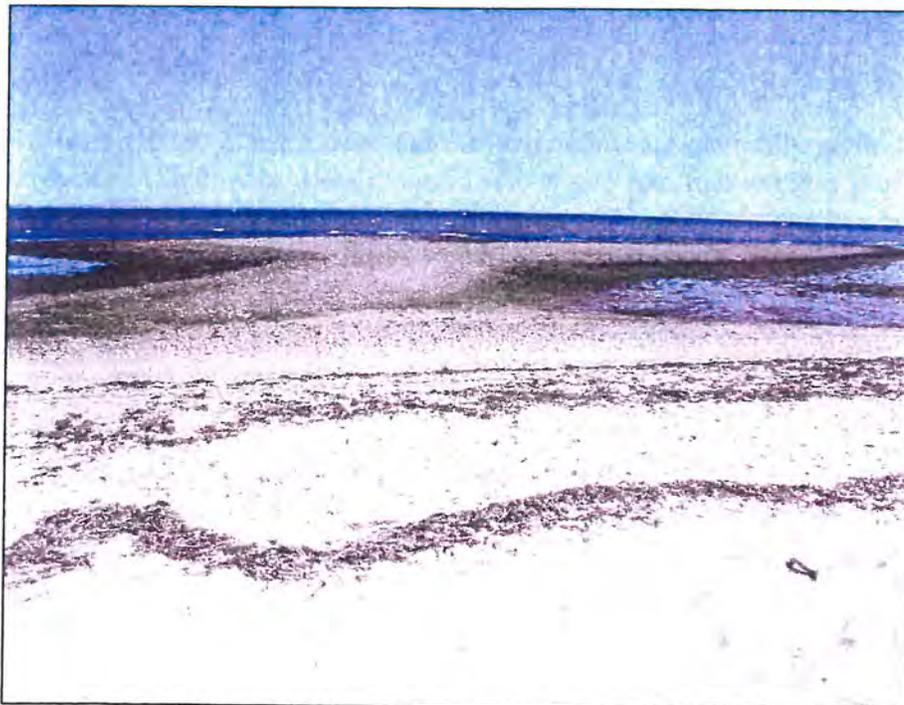
Photo 5.3-1: Offshore cobble reef (tidal flat) near the area of exceptionally stable beach just west of Crab Meadow Beach.

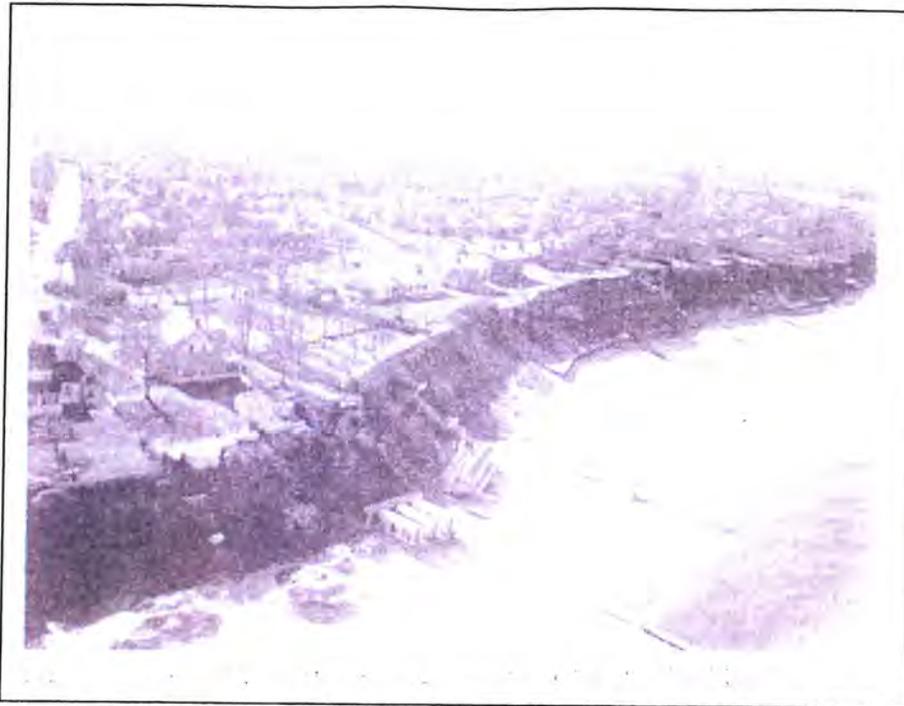
Photo 5.3-2: Groins west of Crab Meadow Beach (from USACE, 1969).

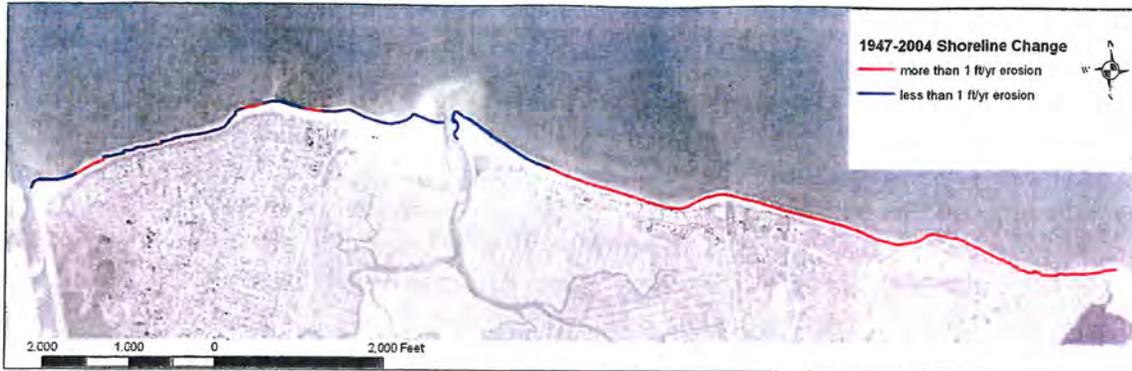
In regards to the standards as outlined in Article 34, Coastal Erosion Hazard Areas (O'Neil, 1998), which was adopted by the Town of Huntington, erosion of more than 1 foot per year is considered high and areas experiencing this level of shoreline retreat are classified as Structural Hazard Areas. Based on the calculated long-term rate, about 55 percent of the shoreline would be classified as such, and includes nearly the entire eastern half of the study area. To this point no Structural Hazard Areas have been defined on the Coastal Erosion Hazard Area maps (New York State Department of State, 1999).

Figure 5.3-2: Areas of erosion and stability over the past 57 years.

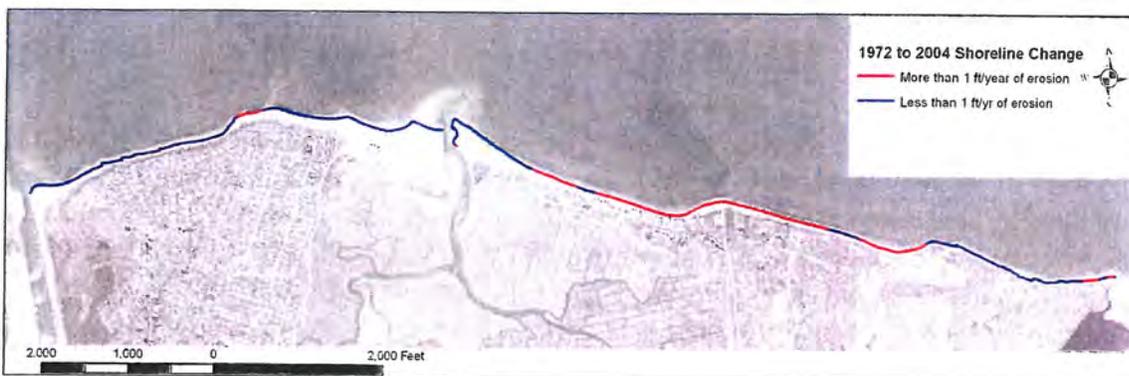
Figure 5.3-3: 1972 to 2004 shoreline change.

The average recent shoreline change between 1972 and 2004 is about half of the long-term rate (0.5 feet per year); this is likely a result of the widespread implementation of erosion control structures. The standard deviation during the period was nearly identical to the long-term at about 1.2 feet per year (fairly uniform change). During this period, 66 percent of the shoreline has some level of erosion at and 33 percent has retreated at a rate of more than 1 foot per year.

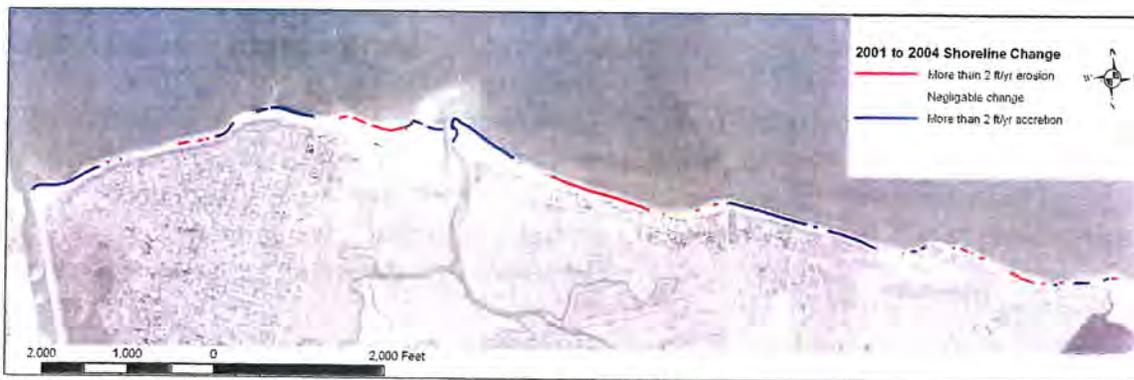
Figure 5.3-4: Shoreline change trends from 2001 to 2004.

The present shoreline change, between 2001 and 2004, actually shows an overall accretionary signature; the average yearly change is 1.75 feet per year. Since this data represents such a short period of time, however, the resolution of the data should be considered. Small errors, those within the range of the technique, are averaged over a limited period and become a larger percent of the result, which is indicated by a six-fold increase in the standard deviation (6.75 feet per year) over the previous data sets. It is more likely that an overall stability has been achieved because areas where the shoreline meets a shore protection structure can no longer retreat at historical rates and those areas with accretional trends, such as the spit at the western end of Makamah Beach and beach near the power plant, continue to advance seaward.

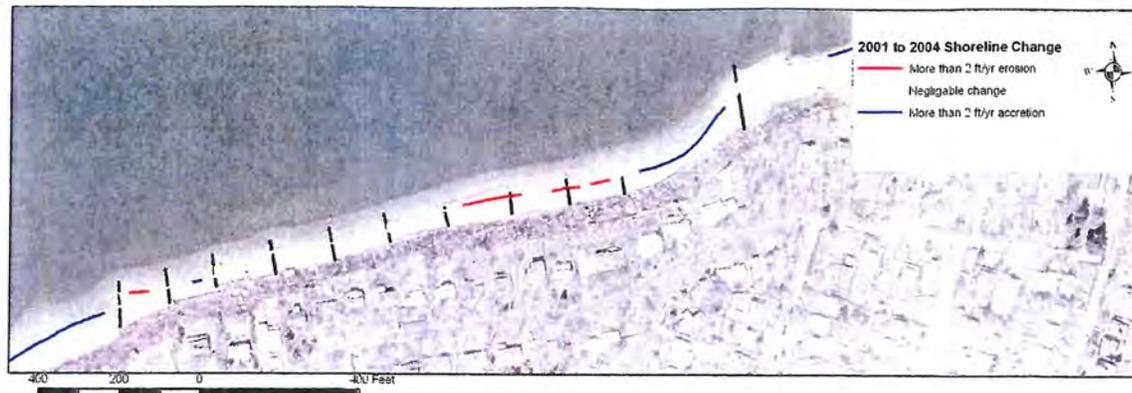
Despite the fact that there are limitations with the data between 2001 and 2004, they are useful for establishing discrete erosion locations or “hot spots” that are vulnerable to episodic events. For example, an area adjacent to a shoreline structure that has experienced heightened erosion could be susceptible to increased storm damage even if it is located in an area showing no, or limited, long-term shoreline erosion. A specific example is on the western portion of the study area where there are multiple groins – some functioning, some not – and a long-term and recent trend of stability. There are areas within this groin field that have present erosion rates of more than 2 feet per year that probably represent episodic events. If the trend continues, episodic events or a series of events may begin to undercut erosion control structures (bulkheads) and destabilize the bluff.

Figure 5.3-5: Discrete “hot-spots” in an area with multiple groins.

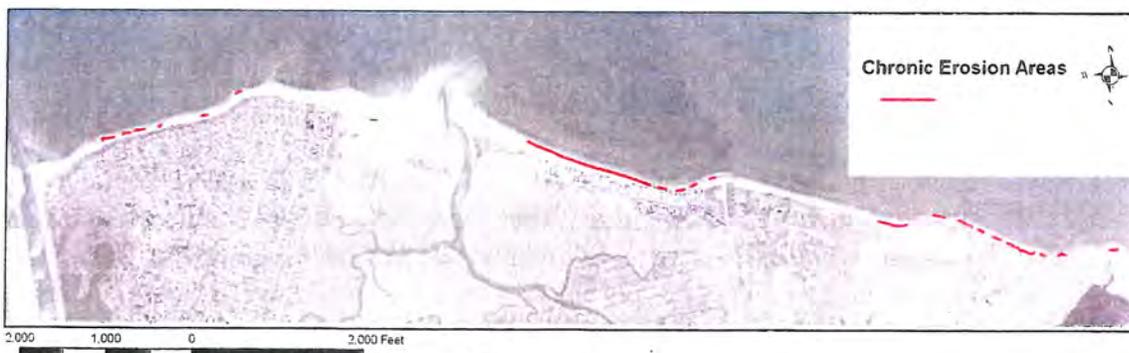
Figure 5.3-6: Areas with a consistent history of erosion.

The areas of concern are clearly Makamah Beach and the eastern portion of the study area. The western portion of the study area may also experience erosion caused problems in discrete areas.

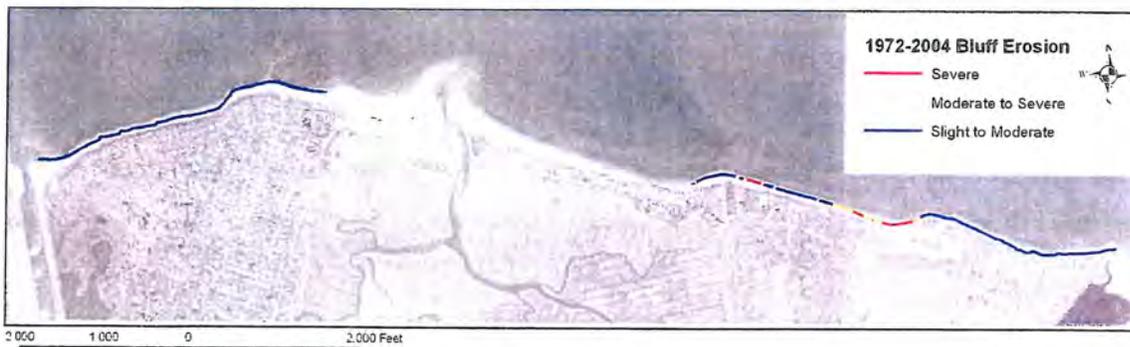
Figure 5.3-8: Bluff erosion from 1972 to 2004.

Moderate to severe bluff retreat in the 1972 to 2004 period (period of intense bluff stabilization and bulkheading; NYS Sec of State, 1999) is generally found in areas that either have failing structures or have no structural stabilization measures. The bluffs just east of Makamah Beach Road that are not stabilized are likely in the most jeopardy of continued severe bluff retreat. Bluffs with slight to moderate erosion have historically been protected (Waterview Street Beach) or are naturally stable. The bluffs on the eastern most end of Geissler's Beach are a good example of naturally stable bluffs.

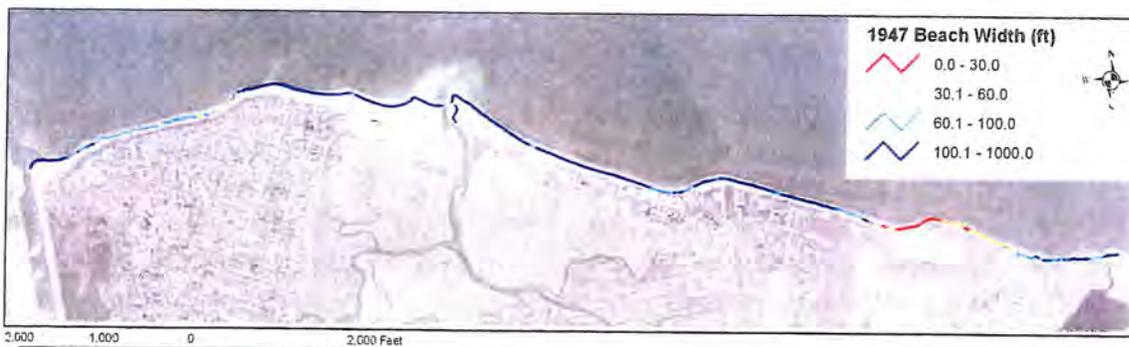
Figure 5.3-9: Beach widths in 1947.

In 1947, narrow beaches primarily occurred in the area known as Broken Ground (Indian Hills Golf Course) probably because much of the sediment eroding from the bluffs consisted of clay sized grains, which are easily transported away in suspension. Of the barrier beach / spit sections of shoreline, only the area just west of Makamah Road is classified as narrow to moderate.

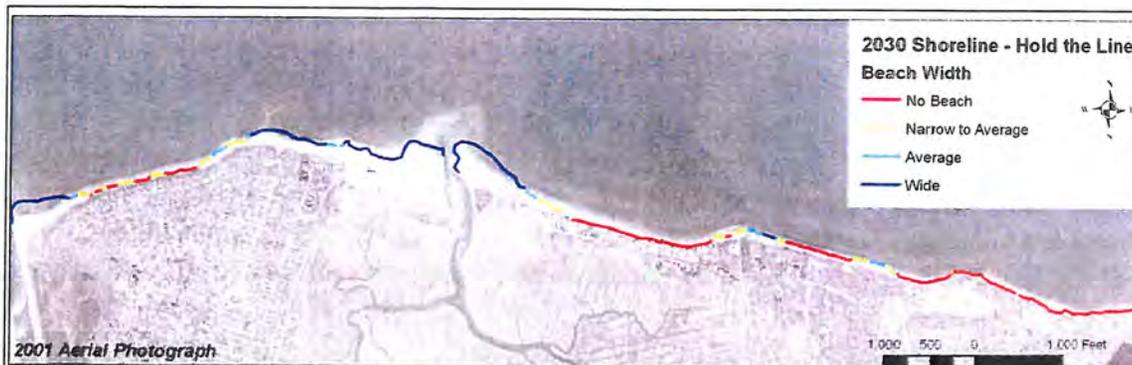
Figure 5.4-2: Map of 2030 Hold the Line shoreline location and beach widths.

Based on this scenario, about 1/3 of the study area will have no remaining beach fronting shoreline protection structures. Areas that have seen accretion will continue to do so, which may lead to a 'have and have-not' situation. Essentially all of the sediment on the beaches to the east will be lost. Some of the sediment from the eastern beaches will continue to feed the spit at the

This scenario is consistent with the present strategies of bluff and shore protection and is based on the assumptions that shoreline retreat will stop at the first line of structural shore protection such as a bulkhead (Figure 5.4-2). Shoreline change is based on a weighted combination of long-term, recent, and present change rates so that recent and present trends have greater influence than in the long-term trend scenario.
