TOWN OF HUNTINGTON LONG ISLAND, NEW YORK BEACH EROSION STUDY REPORT

AUGUST 30, 2006
OCC PROJECT # 205073

EXECUTIVE SUMMARY

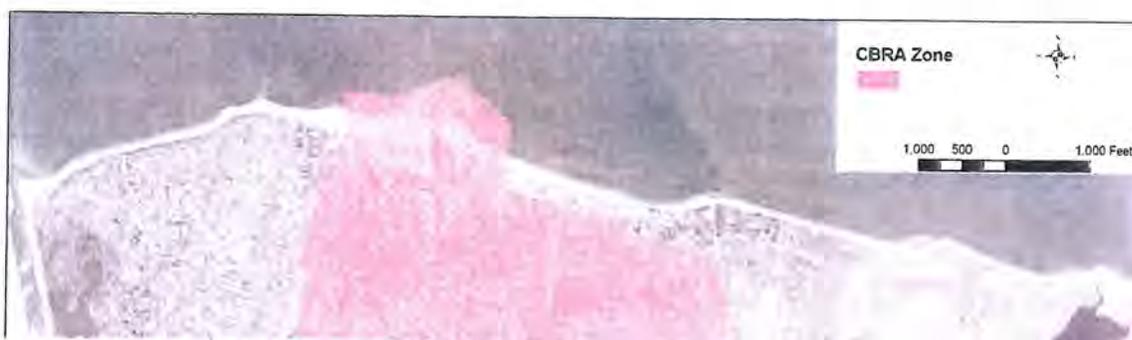
Figure 6.1-1: Coastal Barrier Resources Act zone.

The Federal Emergency Management Agency (FEMA), although not a regulatory branch, does play a role in determining where economically feasible development can occur. FEMA also establishes construction standards and restrictions for structures located within a mapped flood zone. In addition, the Coastal Barrier Resources Act (CBRA) also applies to the study area in that it restricts federally sponsored activities, such as beach renourishment, that promote new development. The CBRA does have exceptions such as federal funding may be provided for nonstructural projects to restore natural stabilization of shorelines. Similarly, section 341 of the Omnibus Reconciliation Act of 1981 terminated Federal flood insurance after October 1, 1983, for new construction or substantial improvement of structures located on undeveloped coastal barriers. The CBRA zone includes Crab Meadow Beach and Marsh areas, however, there are no private properties in the, CBRA (Figure 6.1-1).

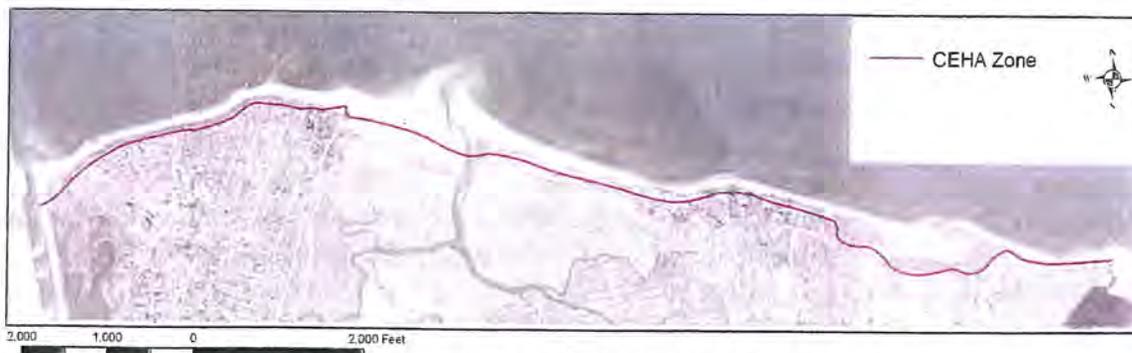
Based on Part 505, development in SHA zones is limited to moveable structures and development in NPFAs is contingent on limiting adjacent or ancillary erosion. It should be noted that no portion of the studied shoreline is defined as a SHA, even though long-term erosion of more than 1 foot per year have been calculated as part of this study. Therefore, further discussions will be relevant to NPFAs. All of the proposed management and stabilization techniques should be consistent with NPFA guidelines at present, with an understanding that SHA zones may be expanded to include some areas of the study area. A partial listing of regulated activities in NPFAs, determined by landform or physiographic location, is presented below. A coastal erosion management permit is still required for "acceptable" activities.

Figure 6.2-1: Map of Coastal Erosion Hazard Area zone within the study area.

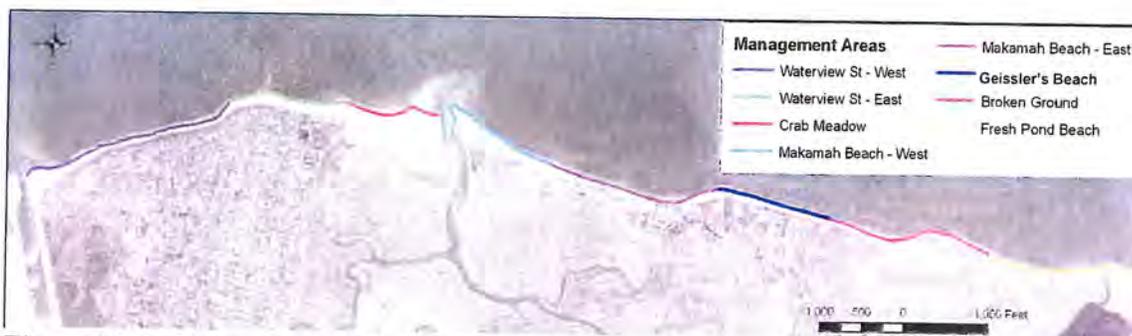
Figure 8.2-1: Management zone overview map.

Management areas have been defined (Figures 8.2-1, 8.2-2, 8.2-3 and 8.2-4) to promote practical use of management recommendations based on location and unique combinations of coastal concerns as discussed above. The management matrix (see Executive Summary) has been divided into areas that reflect these zones.

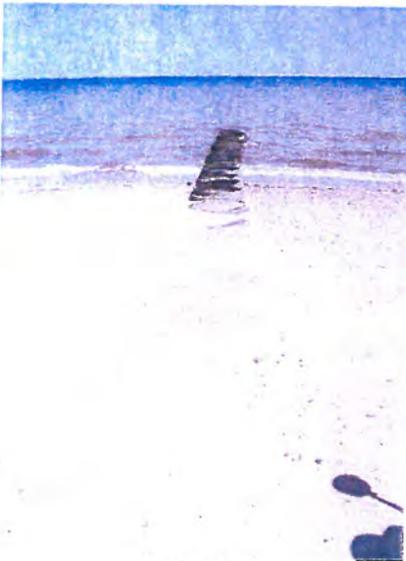
113 (Cretaceous clay outcrop)

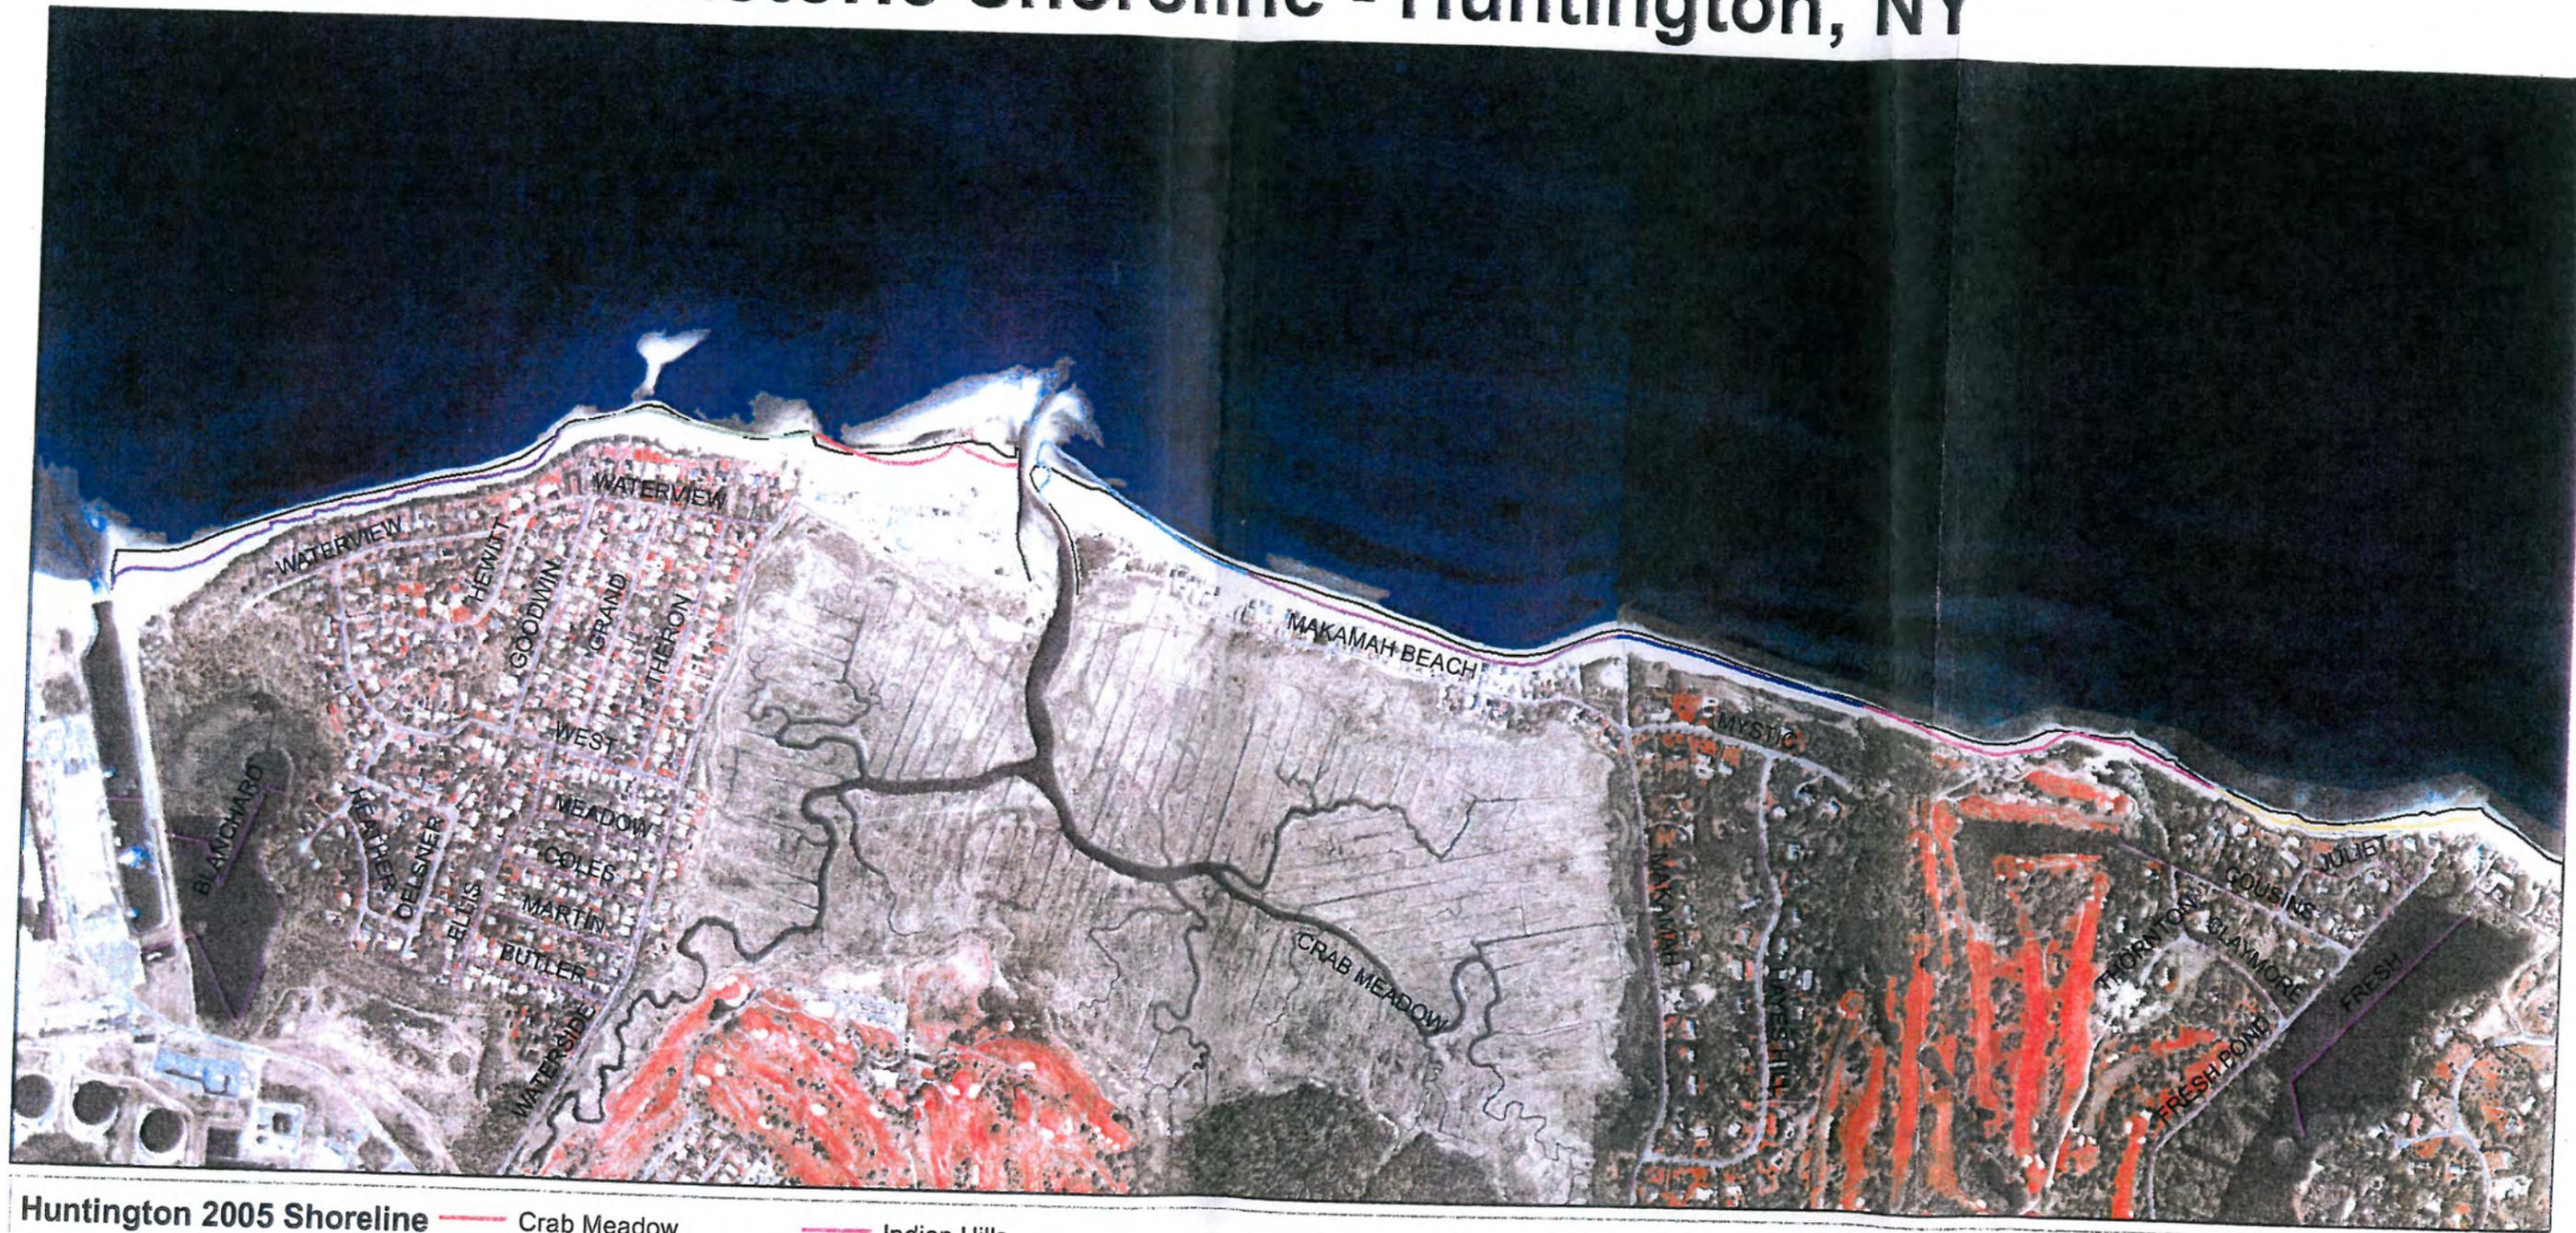
Historic Shoreline - Huntington, NY

- Huntington 2005 Shoreline Management Areas**
- Crab Meadow
 - Makamah Beach - East
 - Waterview St - East
 - Waterview St - West
 - Indian Hills
 - Fresh Pond Beach
 - Makamah Beach - West
 - Geissler's Beach
